Sample Predictive Maintenance Report

Thermographic Analysis

ABC Company

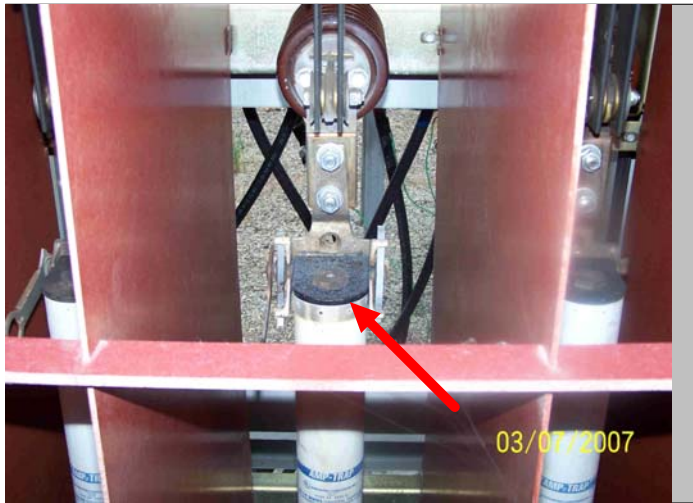
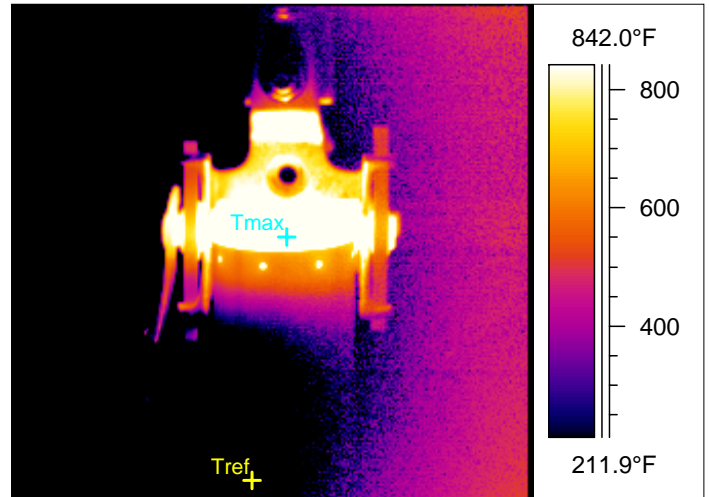
AREA EQUIPMENT	Outside ES-10
-----------------------	------------------

LOCATION PRIORITY	"B" phase line side fuse clip 1 - CRITICAL
--------------------------	--

HOT SPOT TEMP.	>842.0°F
REFERENCE TEMP.	<212.0°F
TEMP. DIFFERENCE	*630.00°F
BACKGROUND TEMP.	39.2°F
THERMOGRAPHER	Chad Furguson

PROBABLE CAUSE	Loose fuse clip hardware.
-----------------------	---------------------------

RECOMMENDATION	Recommend disassembling and cleaning all mating surfaces. Check for loose and distorted hardware and check fuses for corrosion. Replace as necessary. Inspect the surrounding components for signs of damage as well.
-----------------------	---

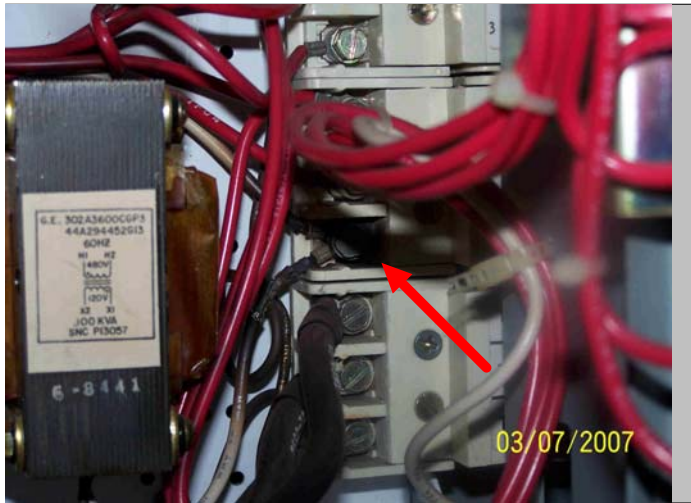
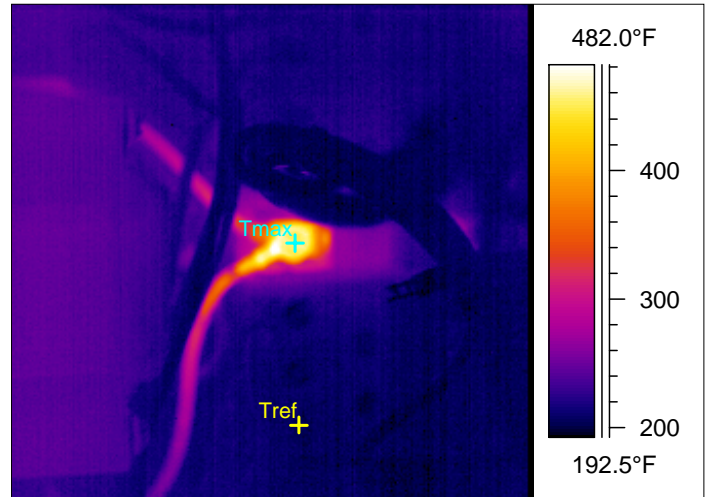
2

AREA EQUIPMENT	GE Room Aux Hyd Filter Pump
-----------------------	--------------------------------

LOCATION PRIORITY	4th screw up on right 1 - CRITICAL
--------------------------	--

HOT SPOT TEMP.	460.0°F
REFERENCE TEMP.	*202.7°F
TEMP. DIFFERENCE	*257.31°F
BACKGROUND TEMP.	69.8°F
THERMOGRAPHER	Chad Furguson

PROBABLE CAUSE	Loose or corroded terminal screw.
-----------------------	-----------------------------------

RECOMMENDATION	Check terminal screw for looseness and repair damaged wiring and terminal block. Check surrounding components for signs of heat related damage.
-----------------------	---

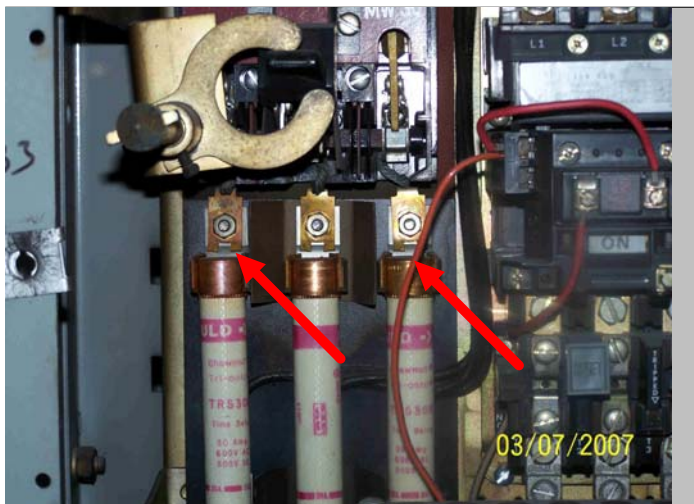
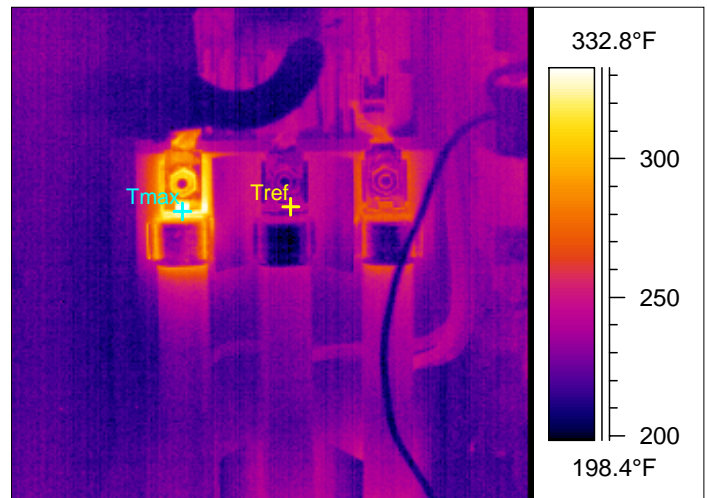
3

RF3 MCC
#2 Filter Pump

"A" & "C" phase line side clips
2 - SERIOUS

AMMETER	Not Available	HOT SPOT TEMP.	330.6°F
ATMOSPHERIC TEMP.	60.8°F	REFERENCE TEMP.	244.2°F
REL. HUMIDITY (%)	0.70	TEMP. DIFFERENCE	86.39°F
CAMERA TYPE	ThermaCAM PM250	BACKGROUND TEMP.	69.8°F
CAMERA SERIAL #	16286	THERMOGRAPHER	Chad Furguson

PROBABLE CAUSE	Loose or corroded hardware.
-----------------------	-----------------------------

RECOMMENDATION	Check for proper fuse clip tension and replace as necessary. Inspect surrounding hardware for signs of looseness or corrosion and clean and tighten.
-----------------------	--

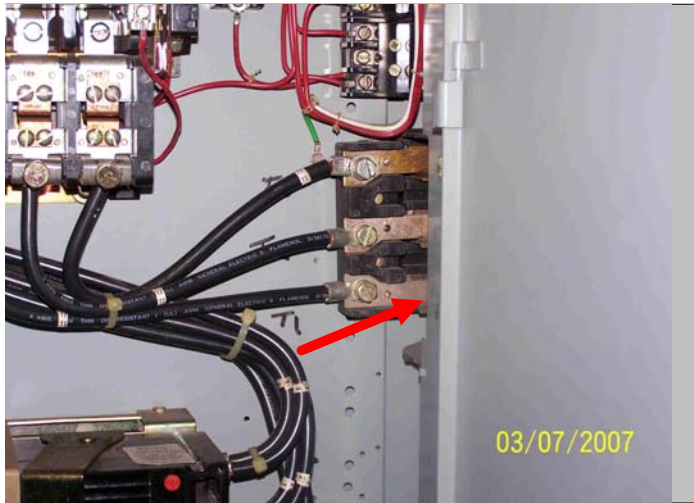
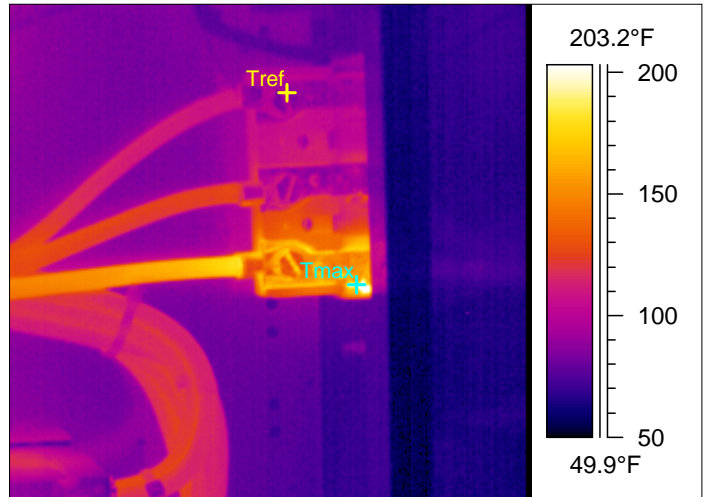
4

Motor Room
RF5 MCC Fume Exhaust

T-1 terminal connection
2 - SERIOUS

AMMETER	Not Available	HOT SPOT TEMP.	189.6°F
ATMOSPHERIC TEMP.	60.8°F	REFERENCE TEMP.	94.5°F
REL. HUMIDITY (%)	0.70	TEMP. DIFFERENCE	95.07°F
CAMERA TYPE	ThermaCAM PM250	BACKGROUND TEMP.	69.8°F
CAMERA SERIAL #	16286	THERMOGRAPHER	Chad Furguson

PROBABLE CAUSE Loose or corroded terminal connection.

RECOMMENDATION Recommend inspecting the terminal block and all connections coming and going to it. Inspect for damaged wiring and replace as necessary.
