# Sample Predictive Maintenance Report

## Laser Alignment

Subject: Laser alignment and vibration test of Central Vacuum Blower.

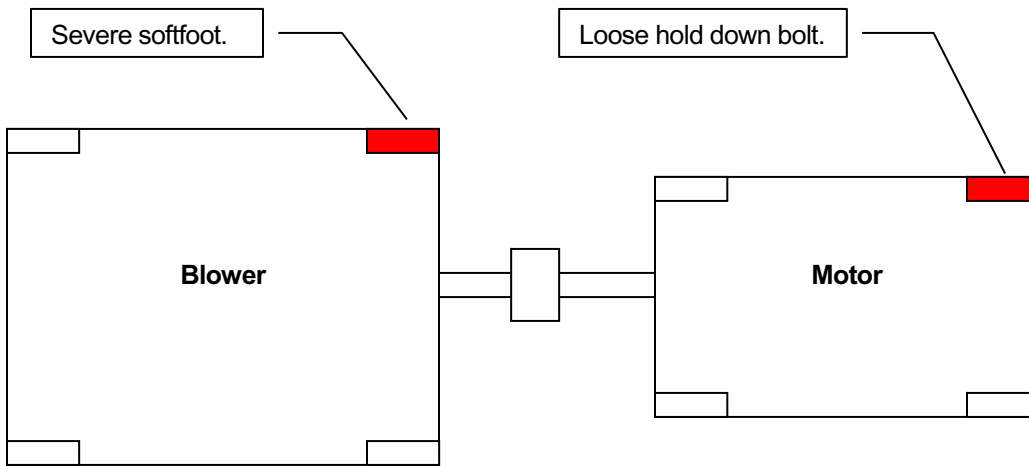
**Figure 1: Machine Overview**

- Identified and repaired a significant sofffoot on the blower and loose foot on the motor (see Figure 1).

- The reduction in overall vibration level in Table 2 is due to the change in alignment as recorded in Table 1.
- No bearing defects were noted on either the motor or blower.
- The remaining vibration on the motor and blower is very directional in the horizontal plane. Advanced vibration diagnostics performed in the field detected a natural frequency at 61.25 Hz, which is just above the motor running speed of 59.12 Hz (3547 RPM, see attached Figure 2). This natural frequency indicates that the structure is sensitive to vibration within +/- 15% of 61.25 Hz, which would include motor running speed. As a result, the vibration levels that remain on the motor and blower are not from misalignment or softfoot, but resonance amplification due to structural/base weakness.

1. After the unit is relocated to its new baseplate, recommend checking alignment and performing another baseline vibration test to determine the effect on the structure stiffness and the natural frequency.
2. If vibration levels remain elevated, consult ISI on making structural modifications to the baseplate in order to alter the natural frequency of the system.
3. Another alternative to making structural modifications is to install a VFD to alter motor running speed away from 61.25 Hz. However, it is important to note that motor speed should not be reduced below 50 Hz as this may excite a natural frequency in the vertical plane at 43 Hz.
4. Continue monitoring this unit on a routine basis using vibration and oil analysis in order to provide early detection of machinery degradation.

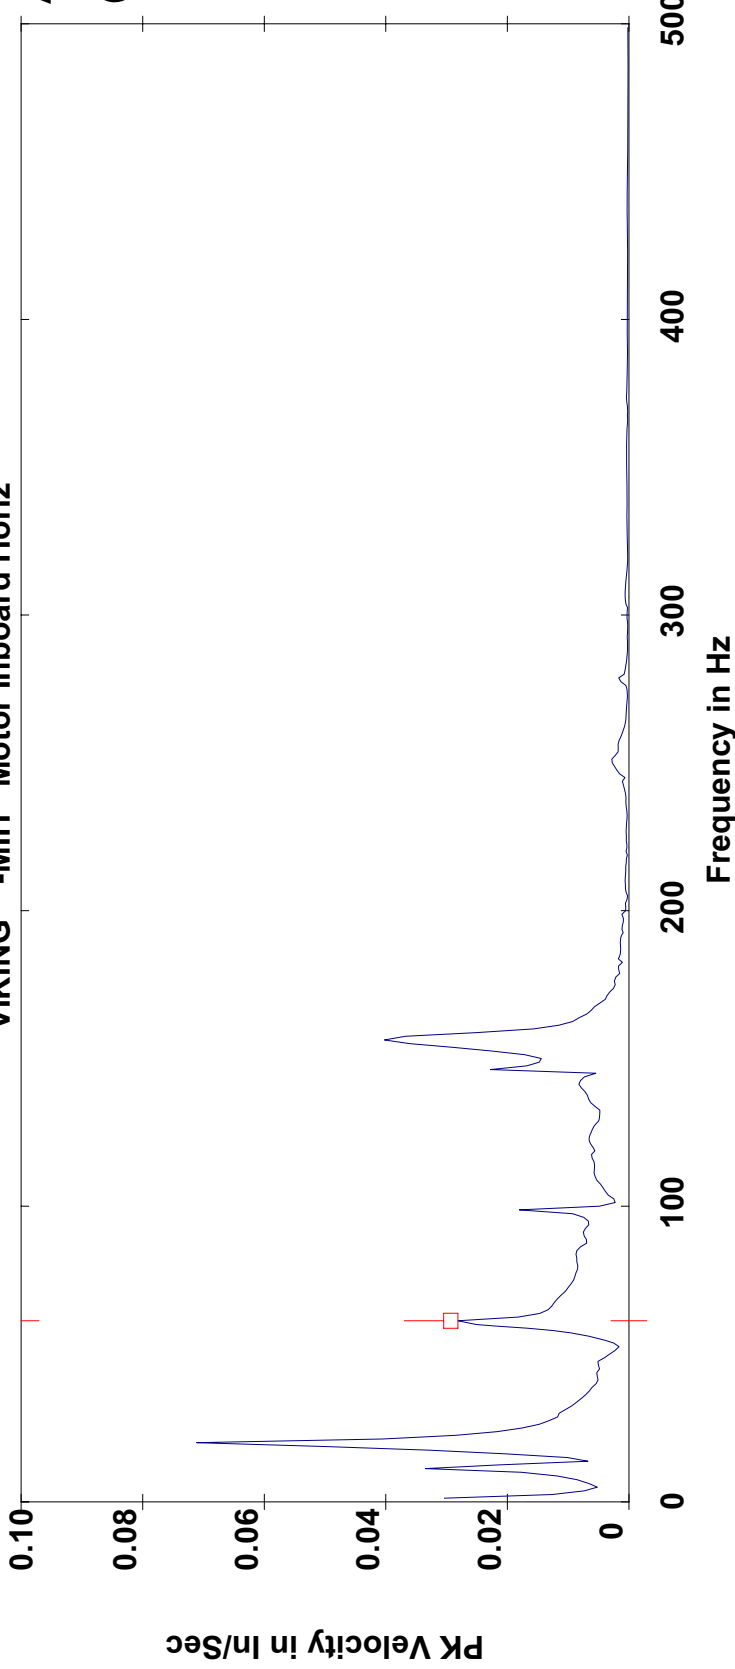
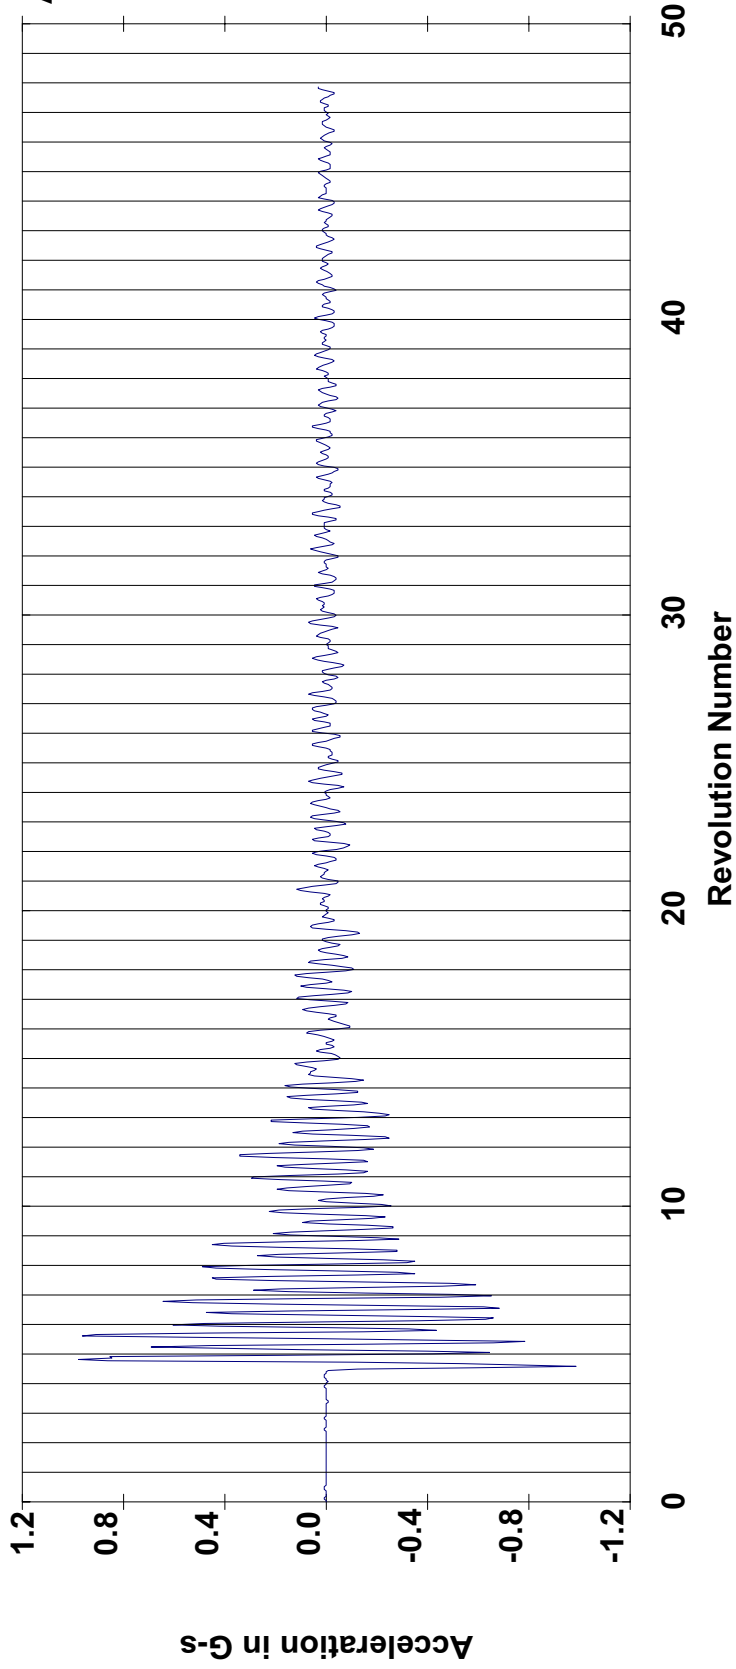
Label: FIGURE 2

PH01 - Viking Blower  
VIKING -MIH Motor Inboard Horiz

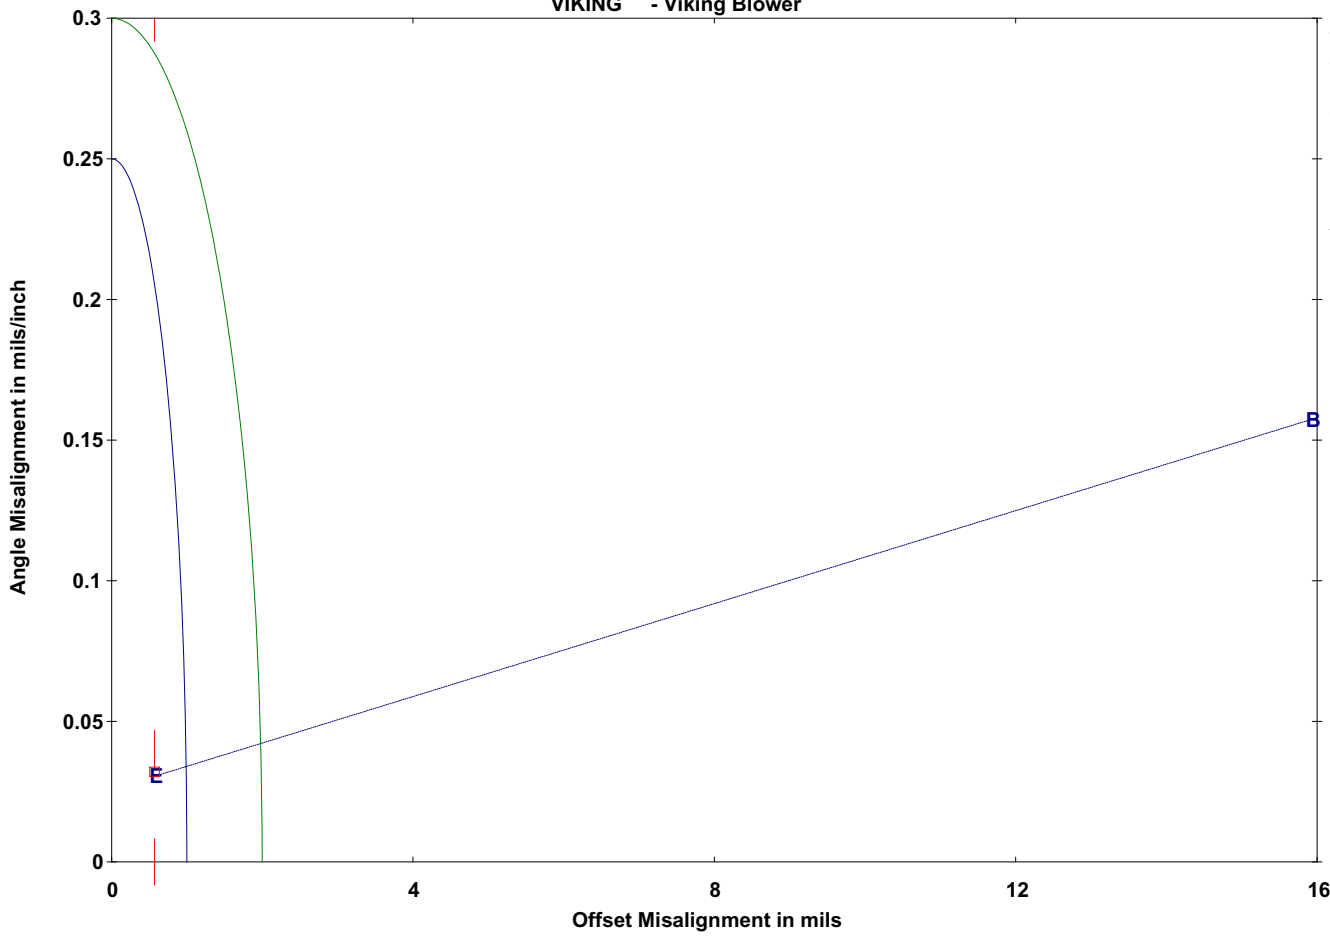
VERTICAL

MOVE END  
OFFS: 0.571  
ANGL 0.03044  
COND EXC

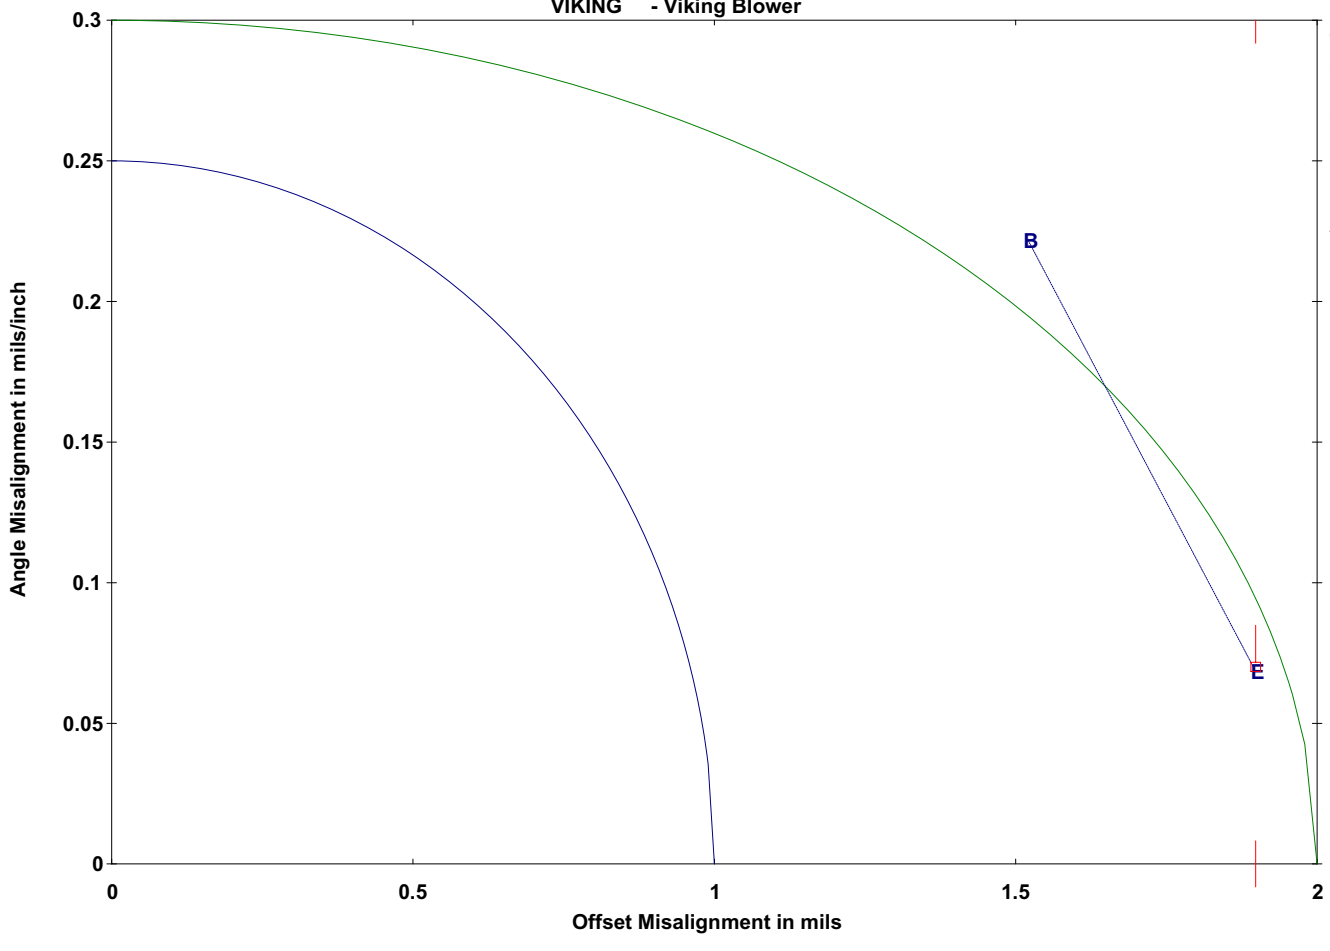
HORIZONTAL

MOVE END  
OFFS: 1.898  
ANGL 0.06849  
COND ACC
