Sample Predictive Maintenance Report

Vibration Analysis

Executive Summary for Vibration Analysis

September 25, 2007

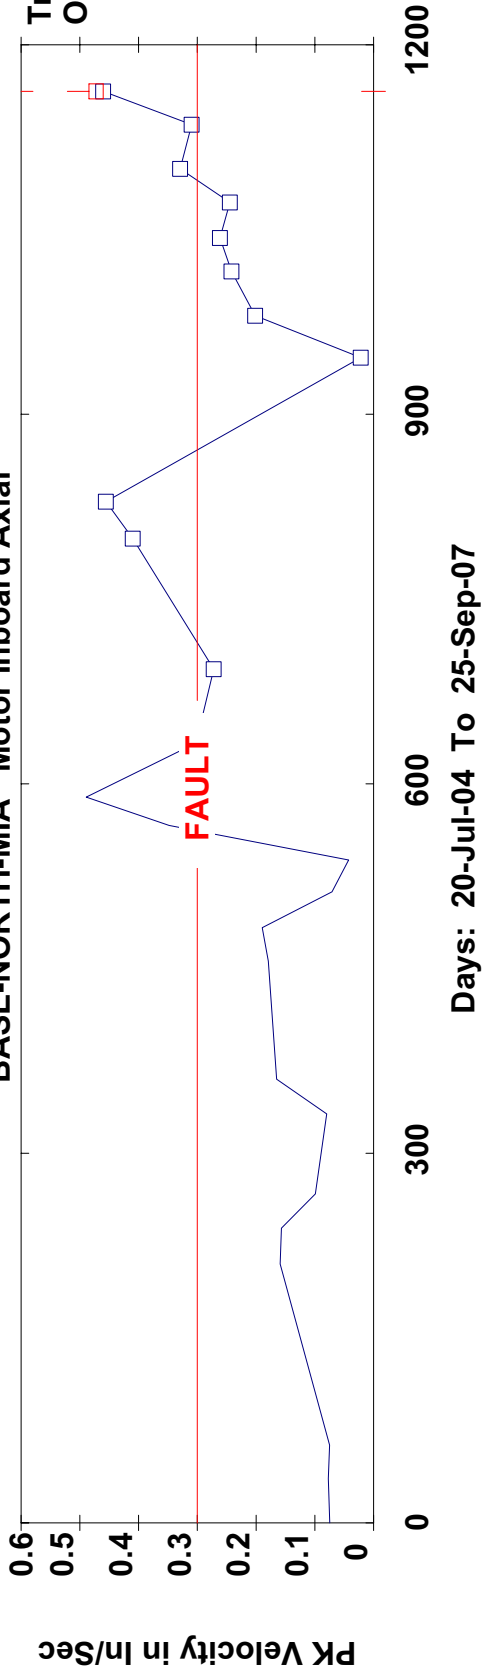
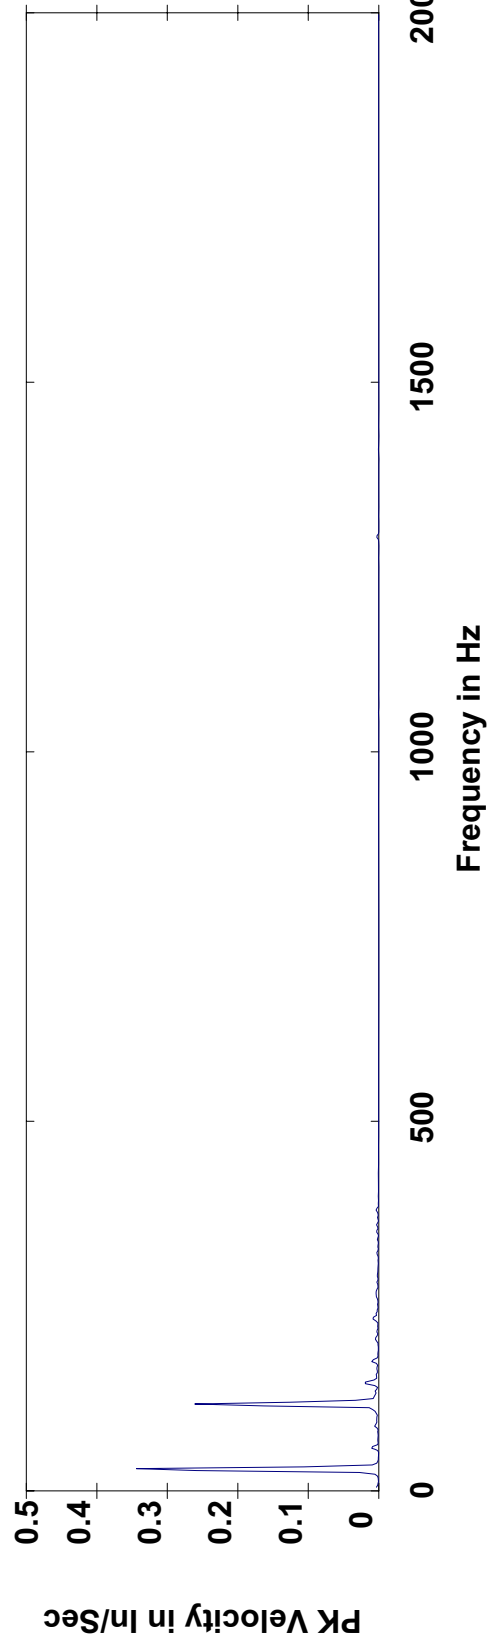
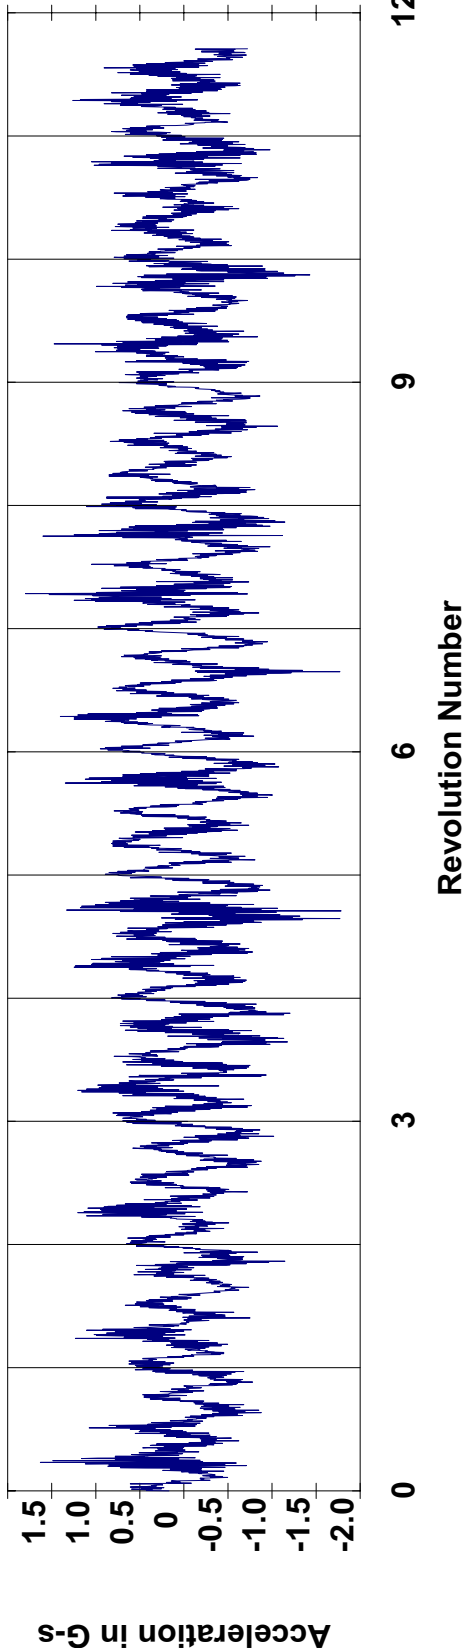
**RES - Base Absorber Pump (North)
BASE-NORTH-MIA Motor Inboard Axial**

Defective motor.

Prior analysis had identified loose bolts on the pump that resulted in a jump in vibration levels. Feedback indicates these bolts have been tightened and the pump has been aligned, resulting in a drop in pump vibration levels. However, overall vibration readings are continuing to increase on the motor and are indicative of a defect with the motor, possibly electrical. Current readings are above alarm levels.

Recommend replacing the motor and performing a laser alignment and softfoot check. Provide feedback to ISI.

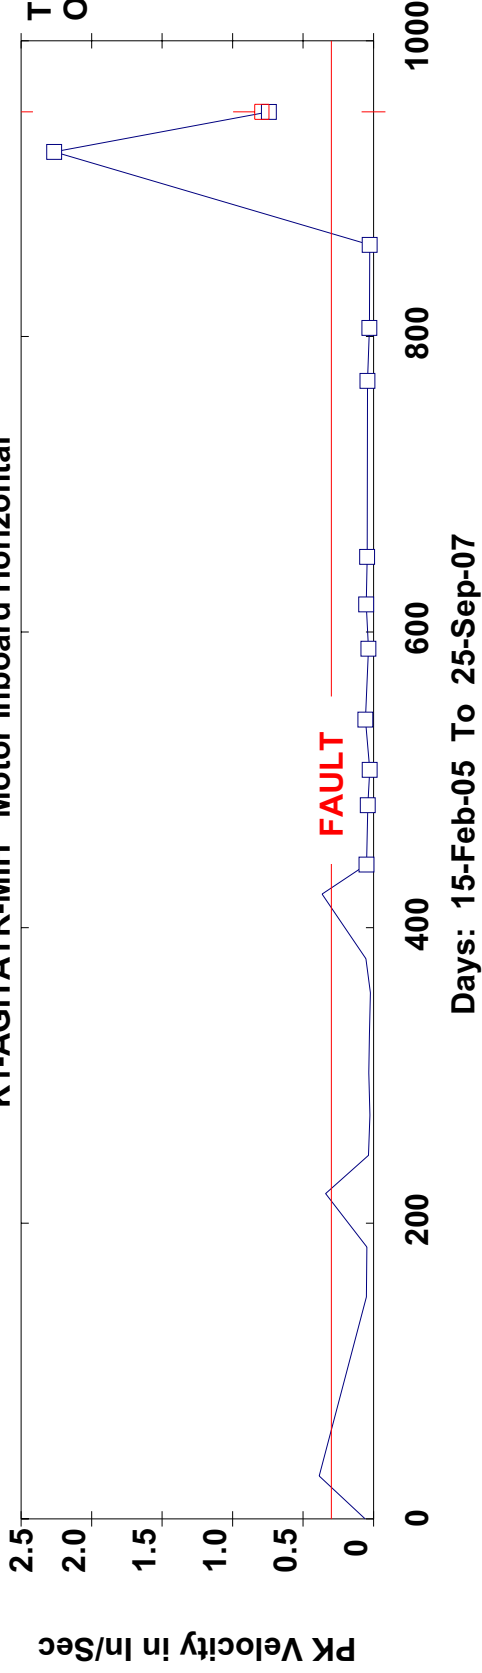
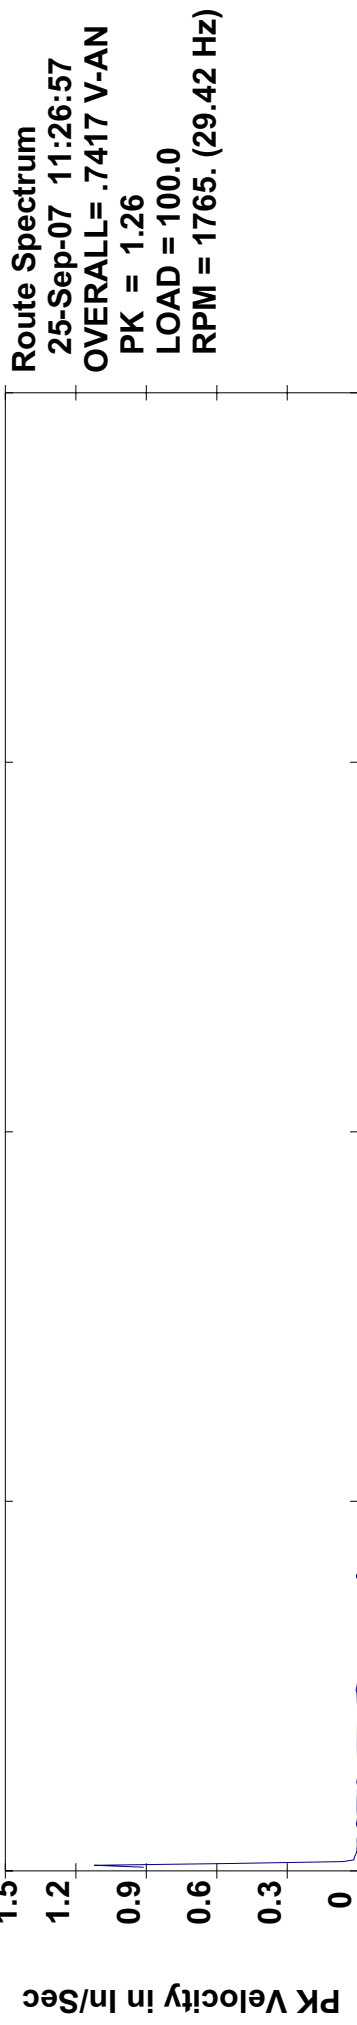
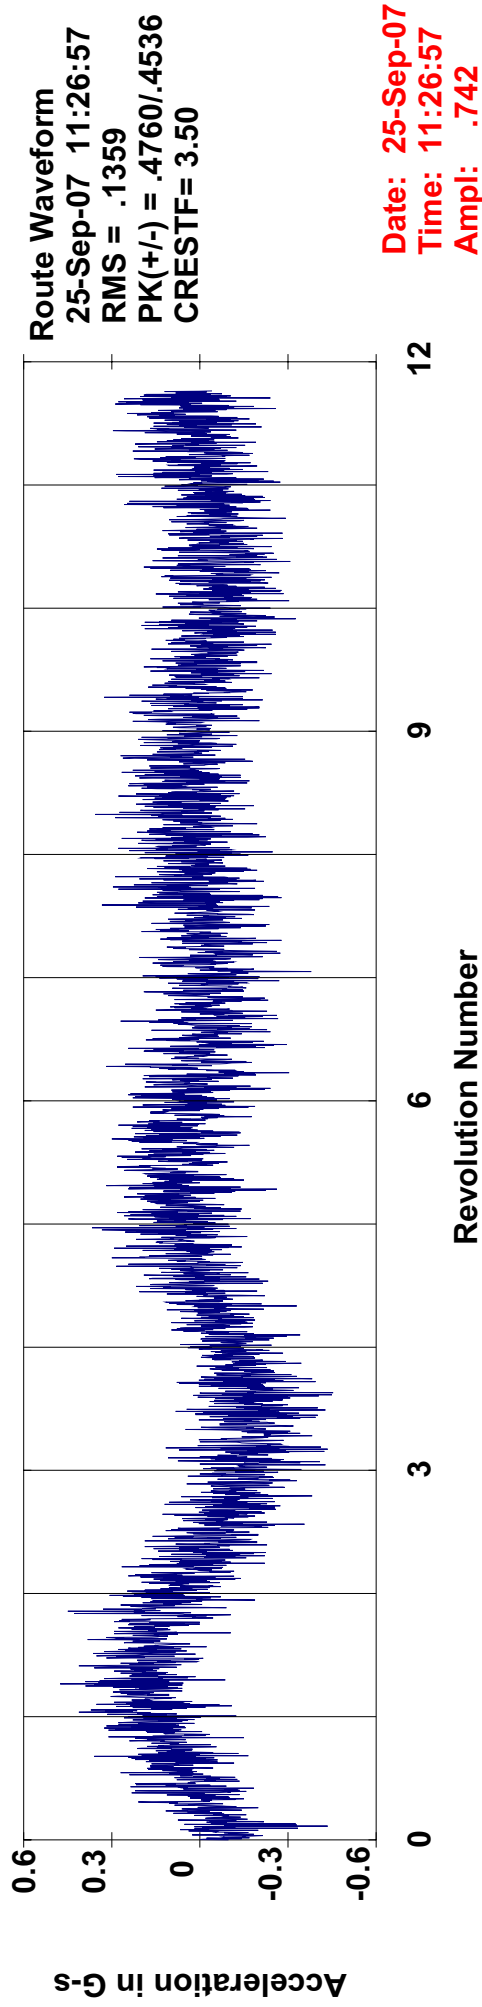
RES - K-1 Agitator
K1-AGITATR-MIH Motor Inboard Horizontal

Process problem.

Vibration levels have decreased since the last service call, but remain well above alarm levels. Although no feedback has been received on this matter, ISI assumes that there is still a process problem that is affecting the operation of the agitator.

Correct the problem with the process ASAP to alleviate the excessive vibration levels. Provide feedback to ISI.

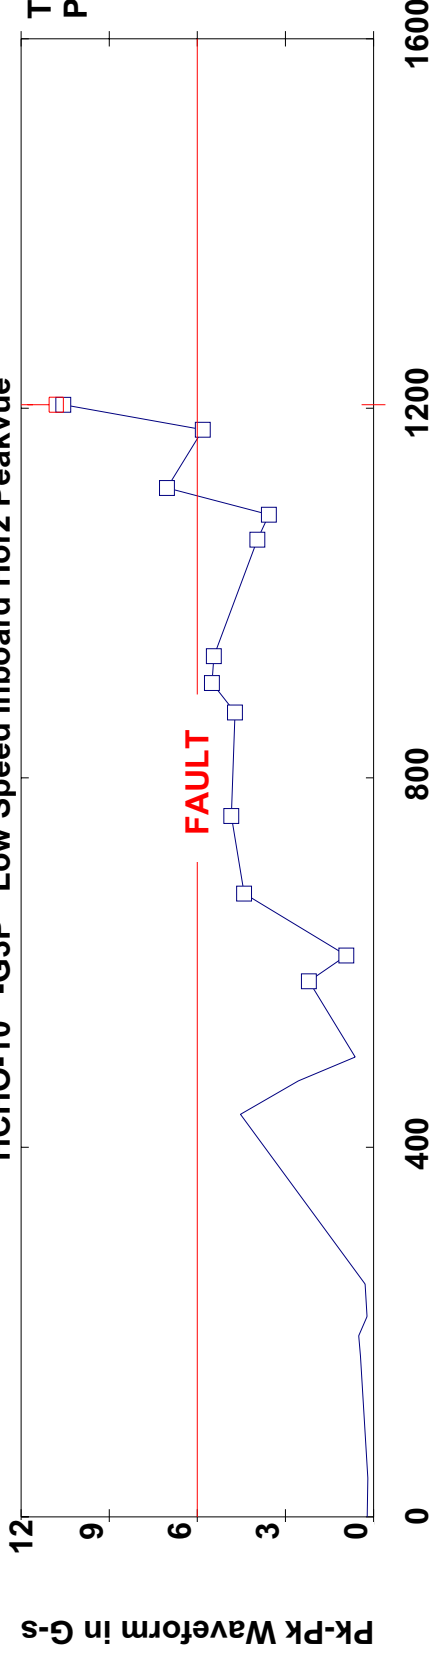
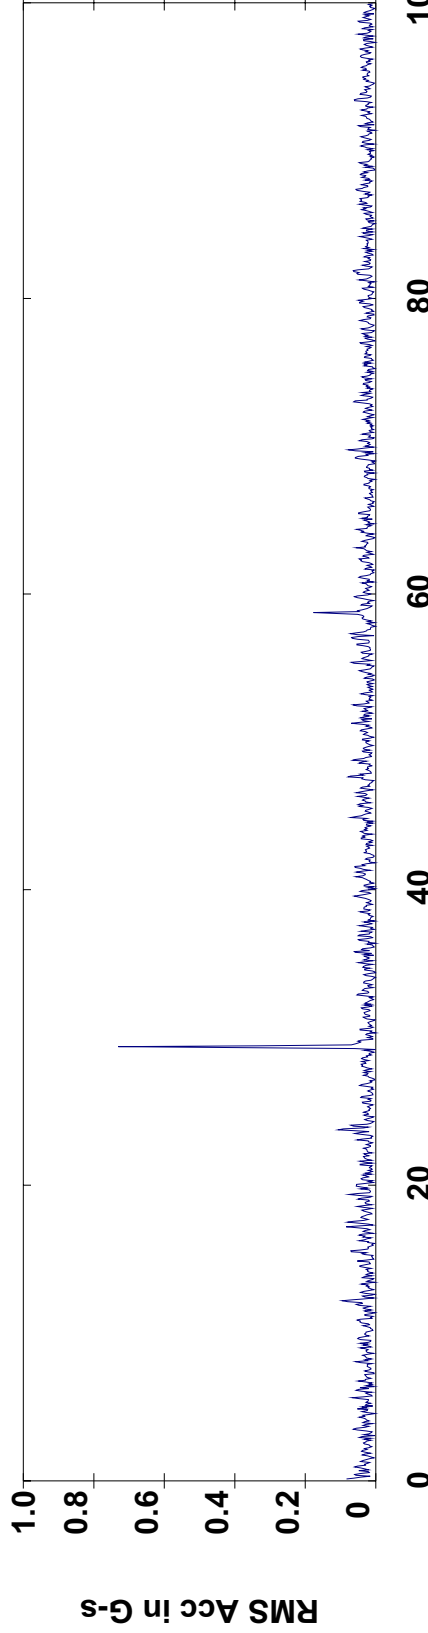
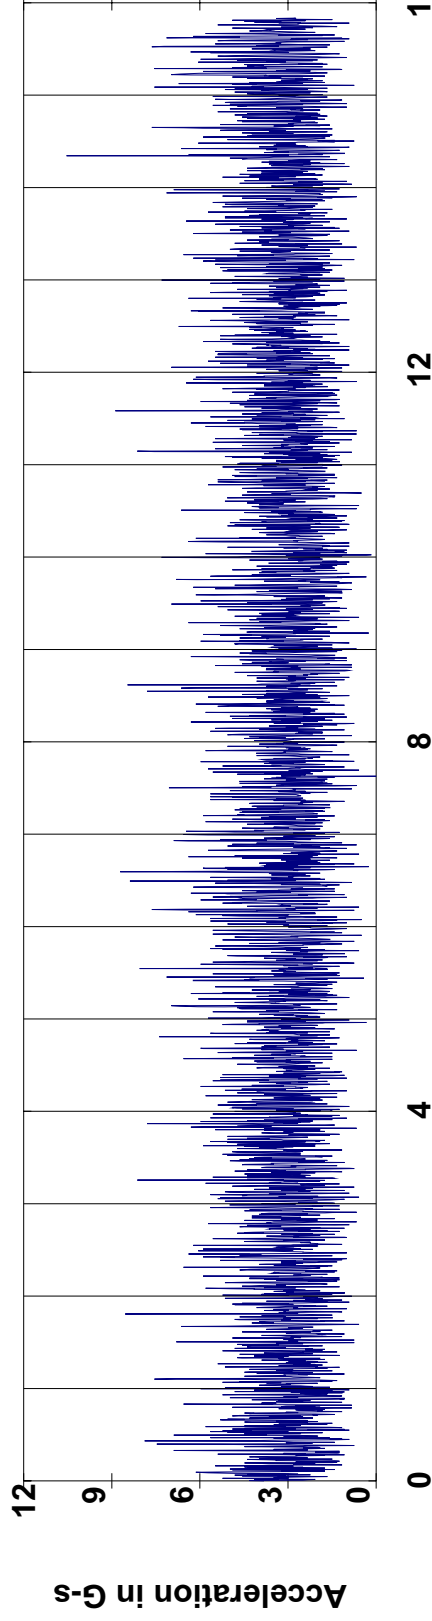
HCHO-10 -G3P Low Speed Inboard Horz Peakvue

Gearbox bearing lube issue.

Feedback from the field indicates this gearbox sounds as if it is running a little dry on lubrication. A review of trend data shows an erratic increase in the amount of friction occurring on the output shaft bearing. Suspect either a lack of oil in the gearbox or the output shaft bearing needs greased.

Recommend checking the lube in the gearbox and grease the output shaft bearing. Provide feedback to ISI.

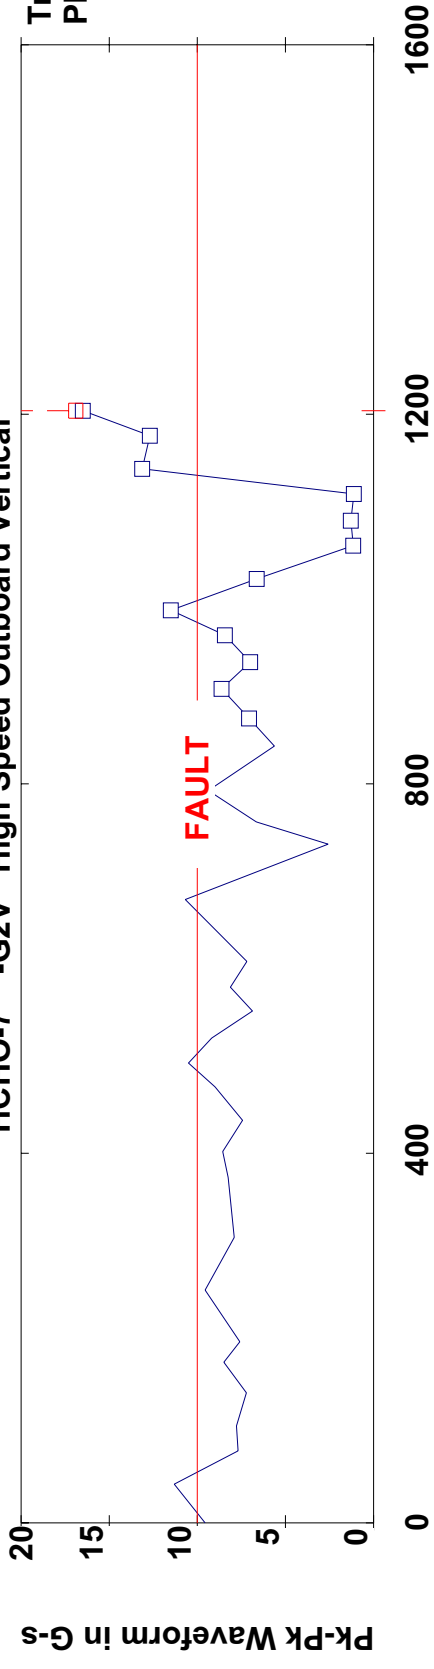
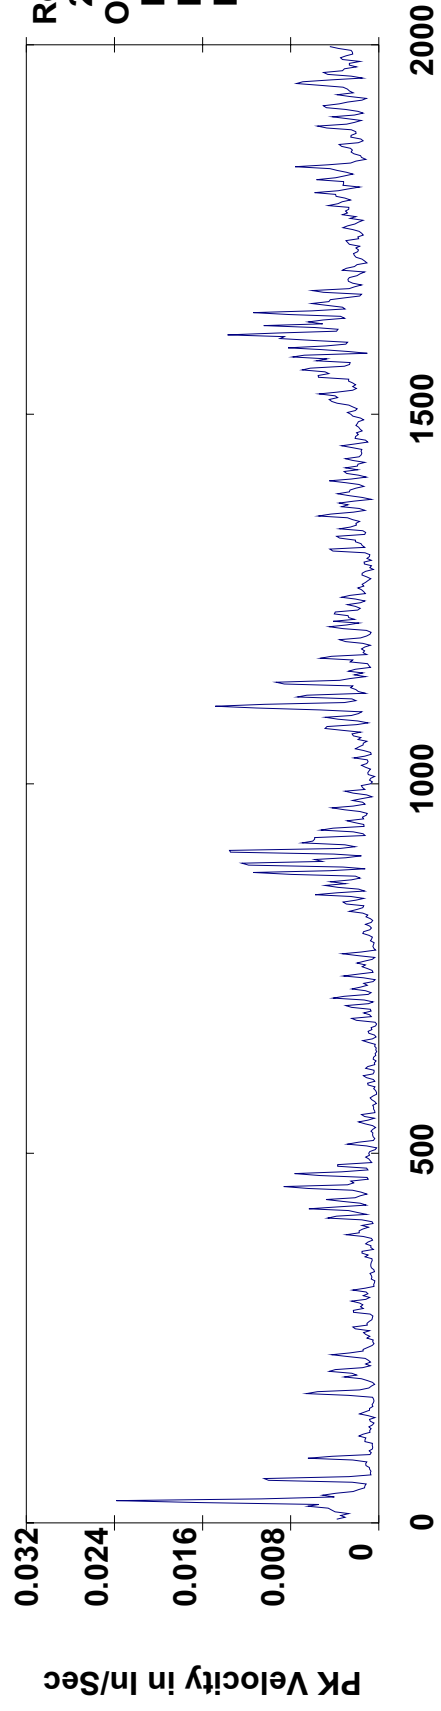
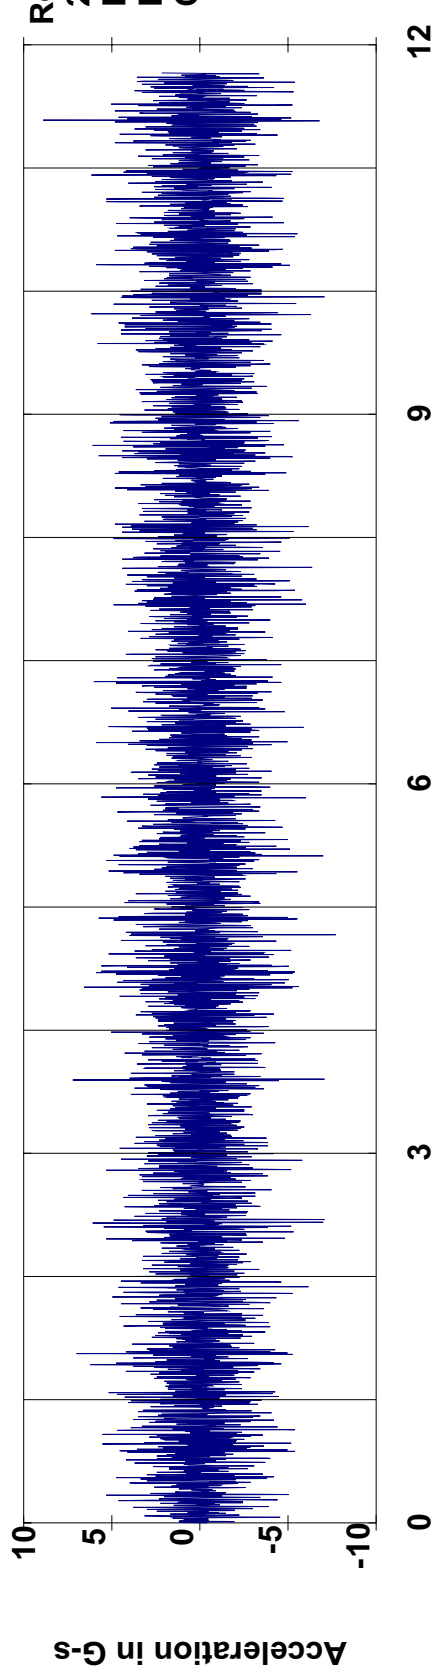
HCHO-7 -G2V High Speed Outboard Vertical

Defective gearbox internals.

As previously reported, levels of impacting on the gearbox and motor are erratic and continuing to trend up. Suspect the cause may be due to damaged gearbox internals. Levels are well above alarm levels.

Recommend drawing a hot 3 ounce oil sample from the gearbox to verify damage is occurring and standby to replace the gearbox. Provide feedback to ISI.

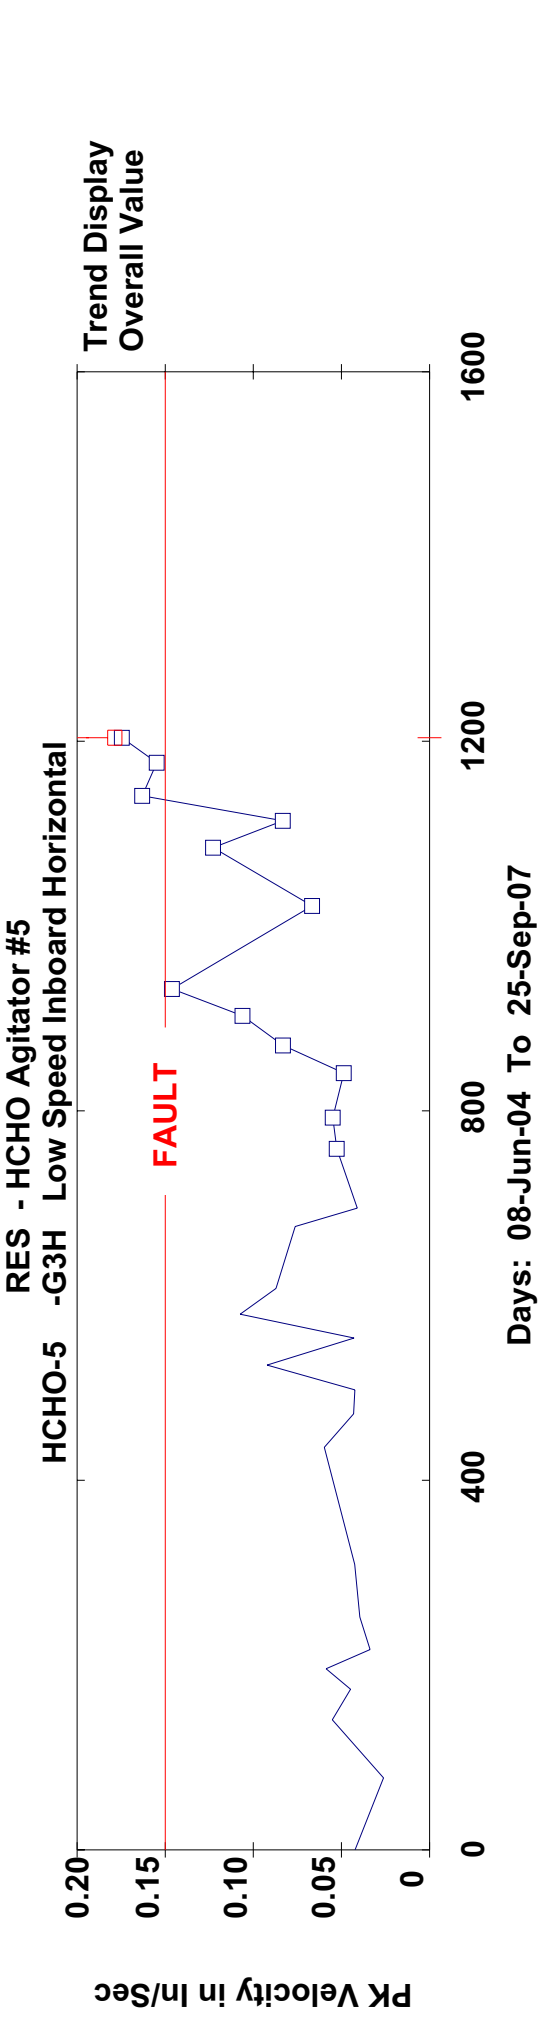
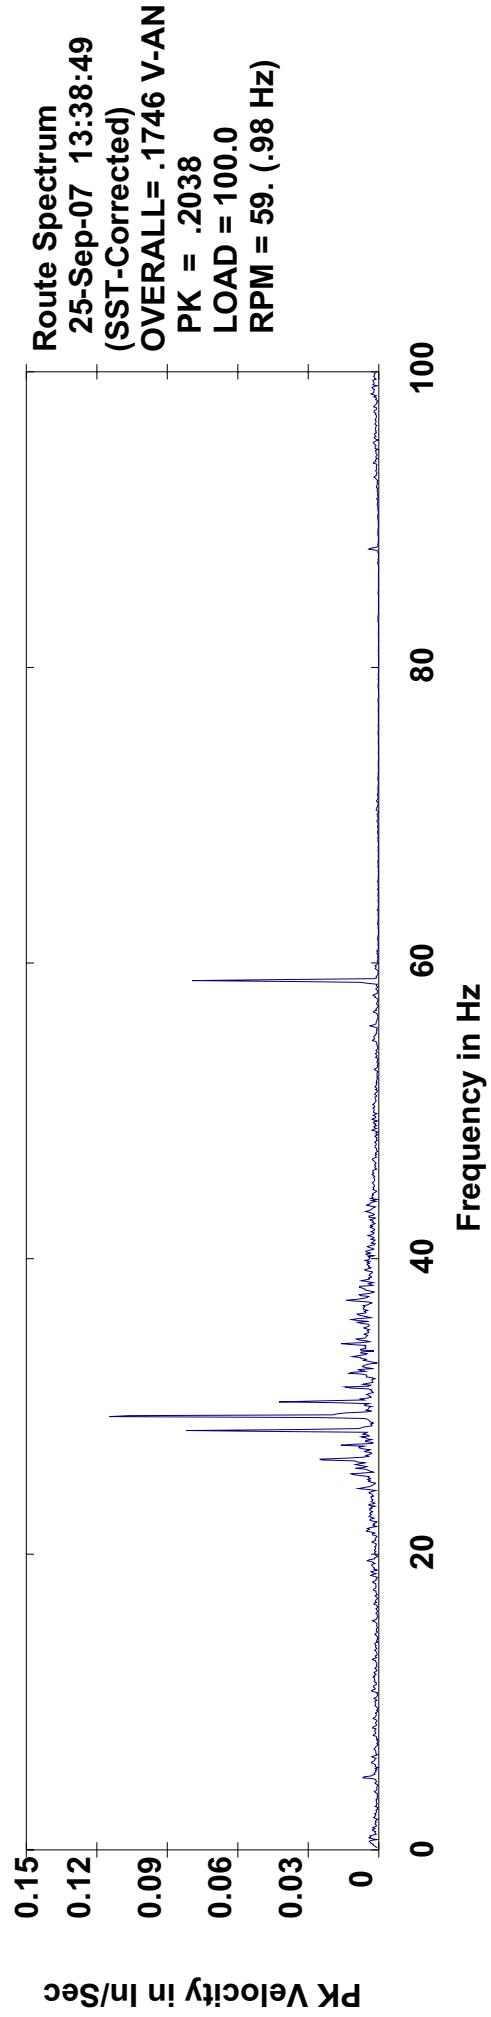
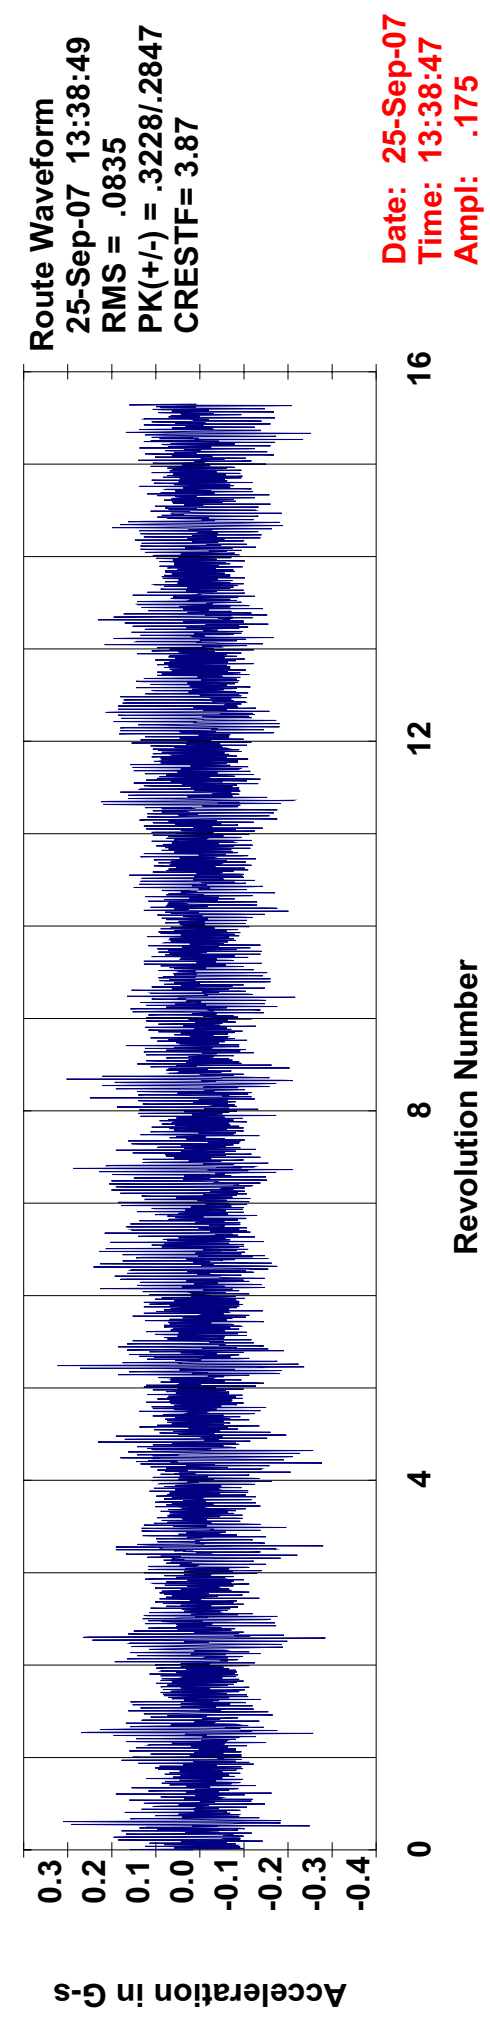
Possible gear wear.

Feedback from the field indicates this gearbox sounds slightly rougher than the others. A review of trend data indicates an erratic increase on some of the gearbox test points that appears to be consistent with gear wear.

Recommend drawing a hot oil sample from the gearbox to confirm the fault and the severity. Standby to replace this gearbox should the trend continue.

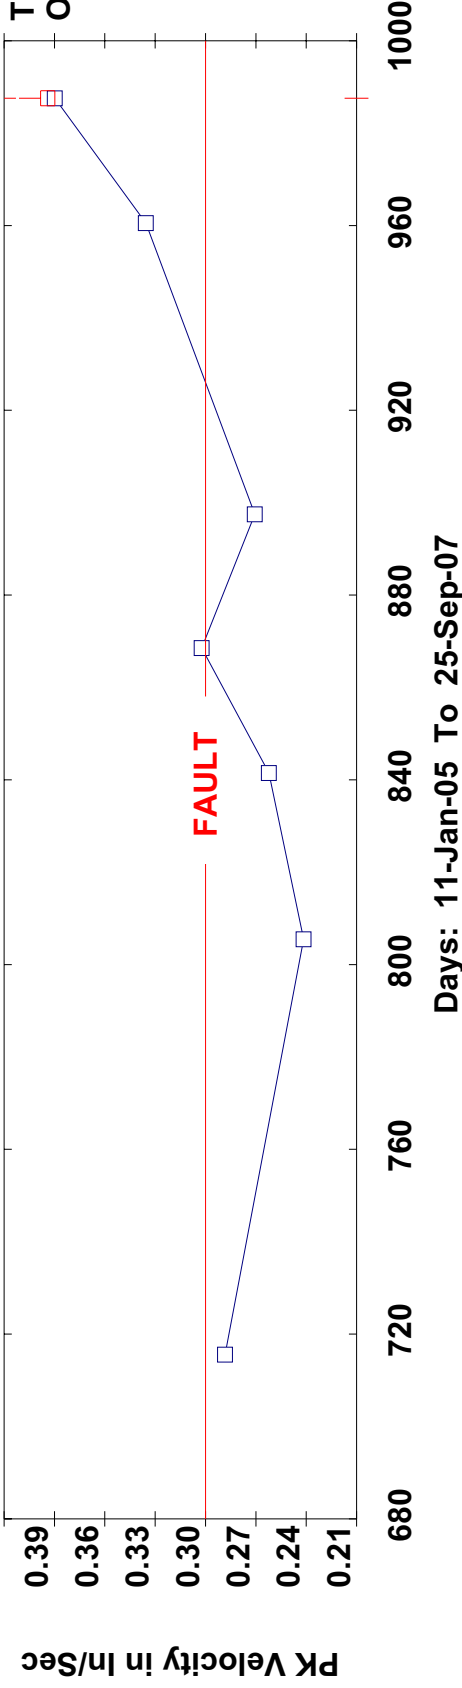
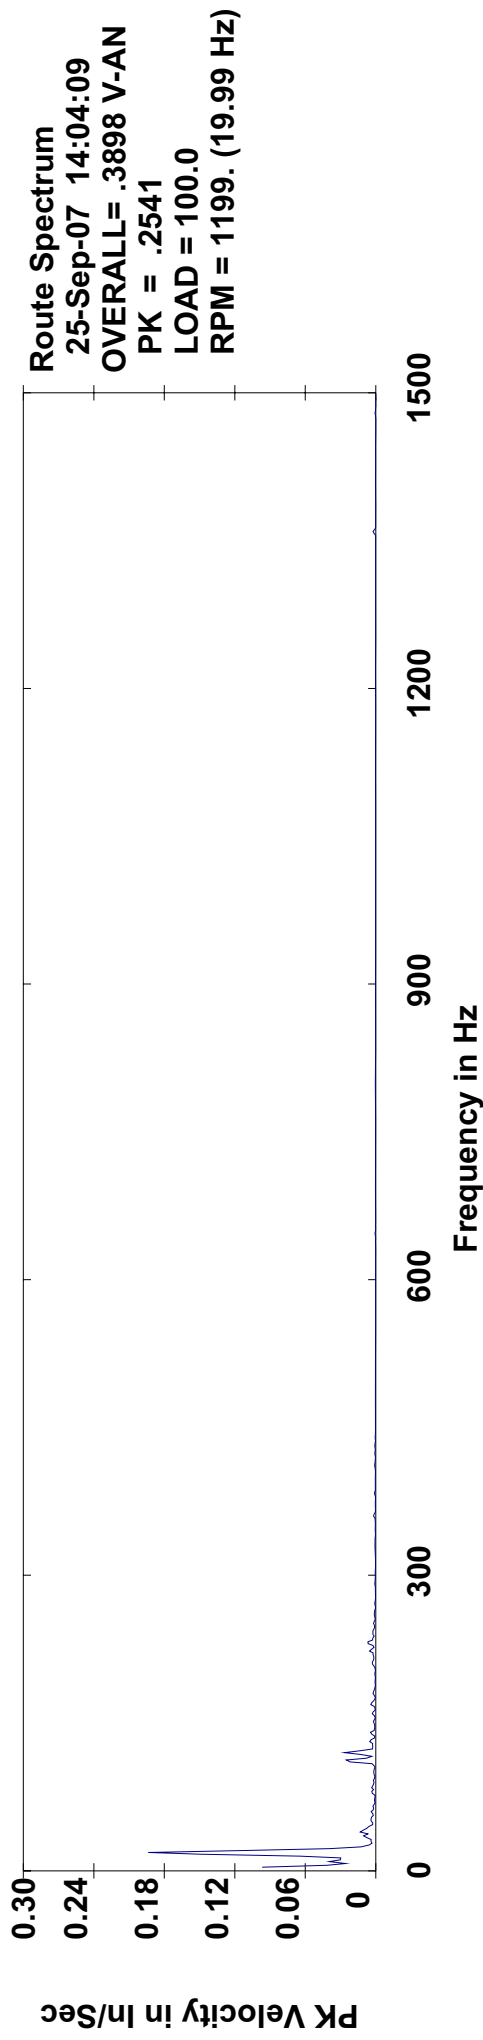
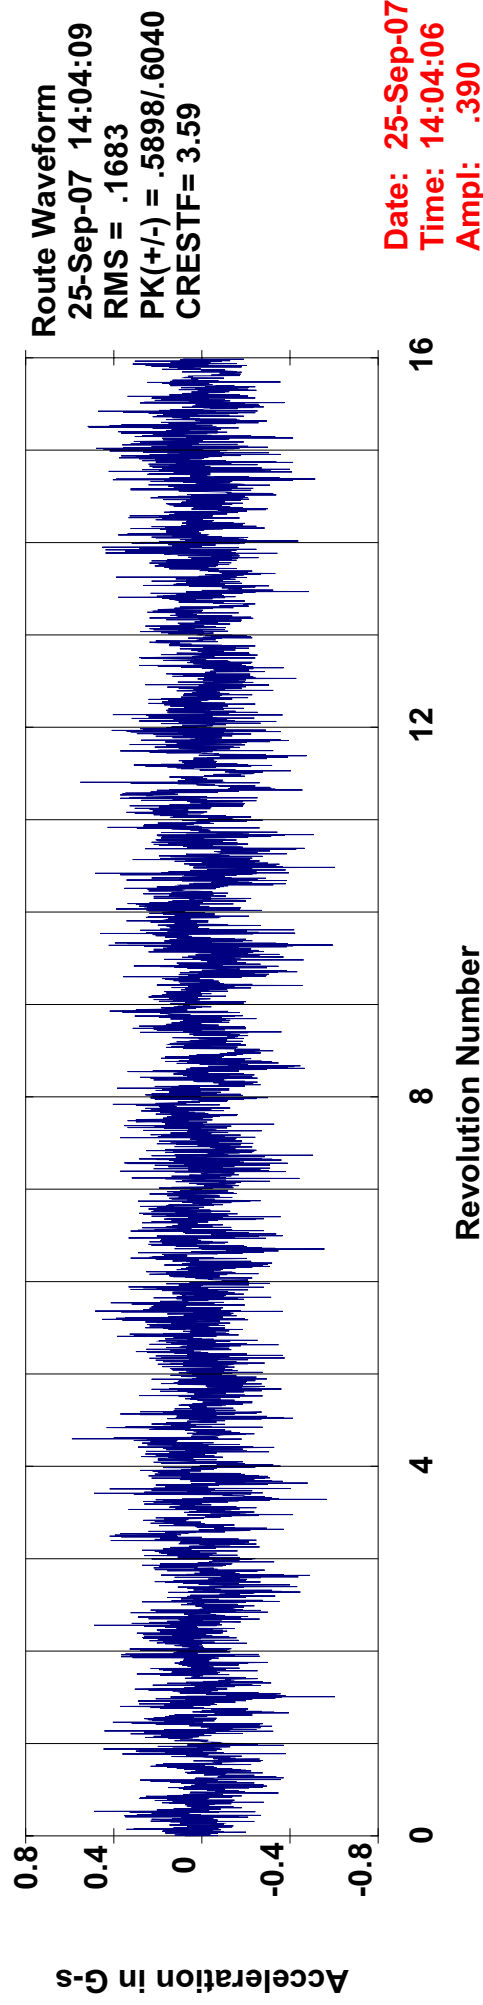
RES - T-1 Agitator
T1-AGITATR-MOH Motor Outboard Horizontal

Structural damage.

Feedback from the field indicates cracks are appearing in the center post that meets the top cross member between the motor and mixer shafts. There also appears to be a large horizontal vibration that may be a contributing factor to the damage.

Investigate the structural damage and make repairs as necessary. Also, determine the reason for the excessive rocking of the structure and provide feedback to ISI.

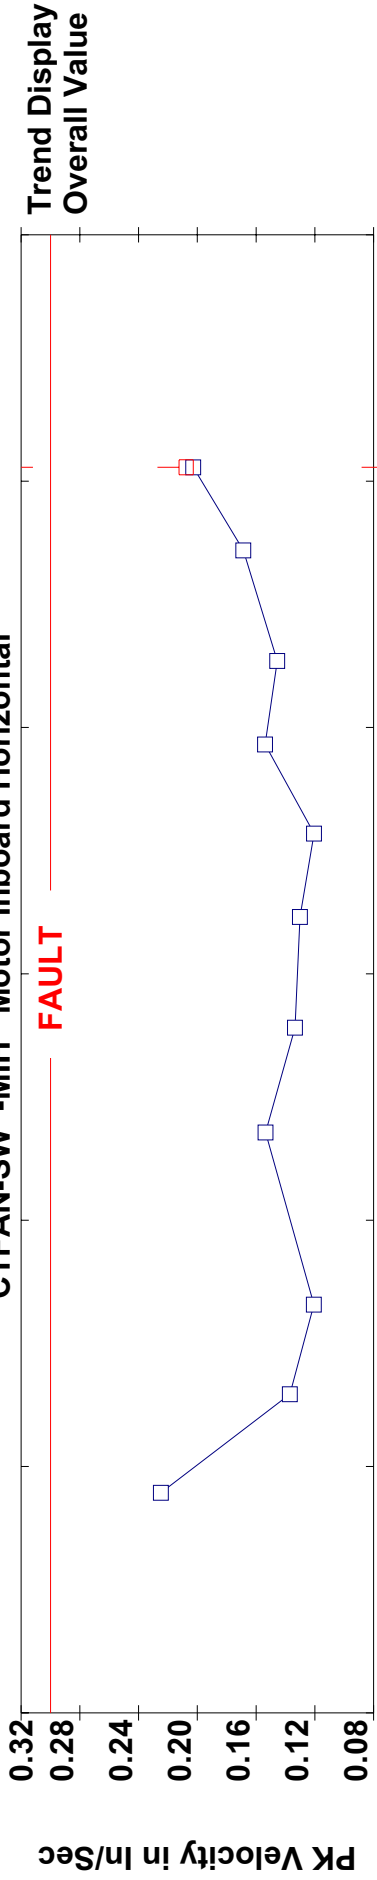
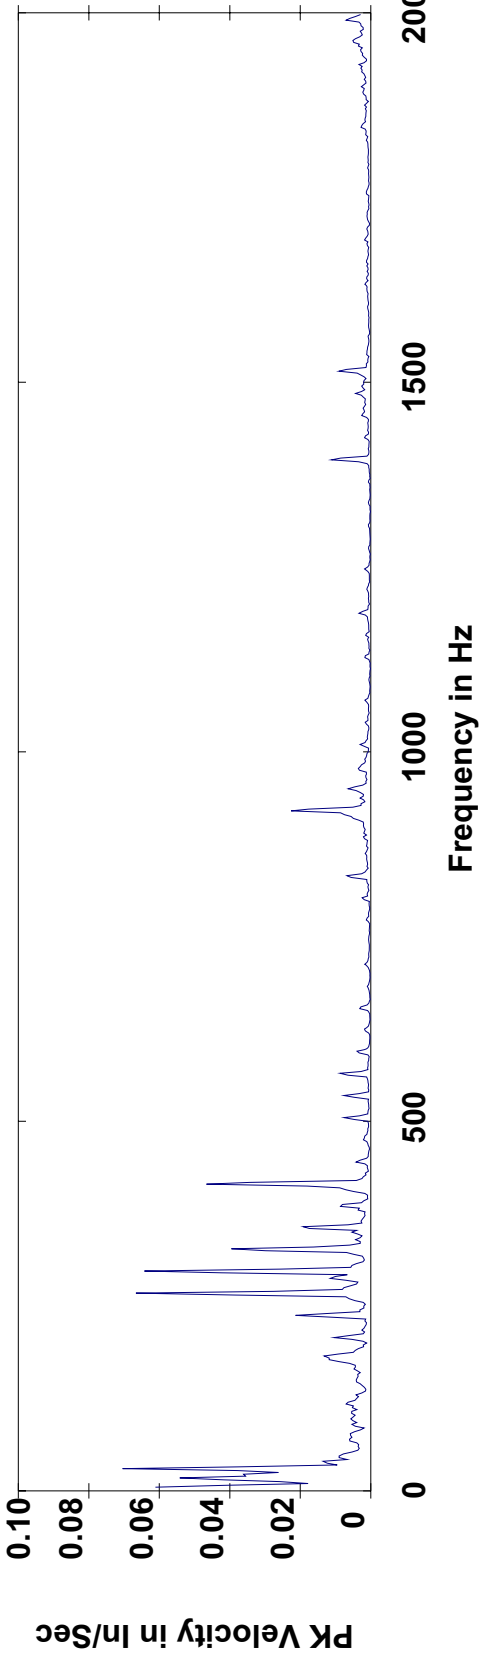
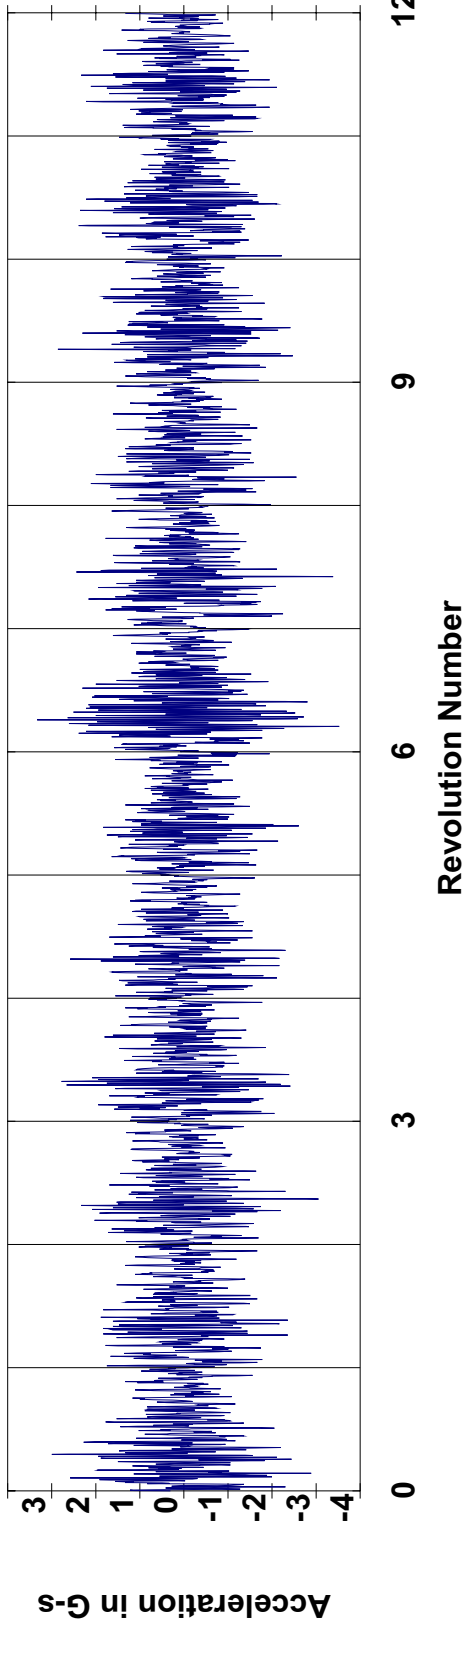
RES - Southwest CT Fan
CTFAN-SW -MIH Motor Inboard Horizontal

Possible loose motor shaft component.

Feedback from the field indicates this motor sounds "rough." A review of trend data indicates a slight upward trend and the possibility of a loose motor shaft component. This would be consistent with the noise being heard from the motor.

Recommend checking the motor shaft for excessive endplay using a dial indicator and inspect for loose or worn shaft components.
