Sample Predictive Maintenance Report

Vibration Assessment Analysis

Subject: Baseline vibration testing of both Gypsum Bleed Pumps and both Mist Eliminator Pumps.

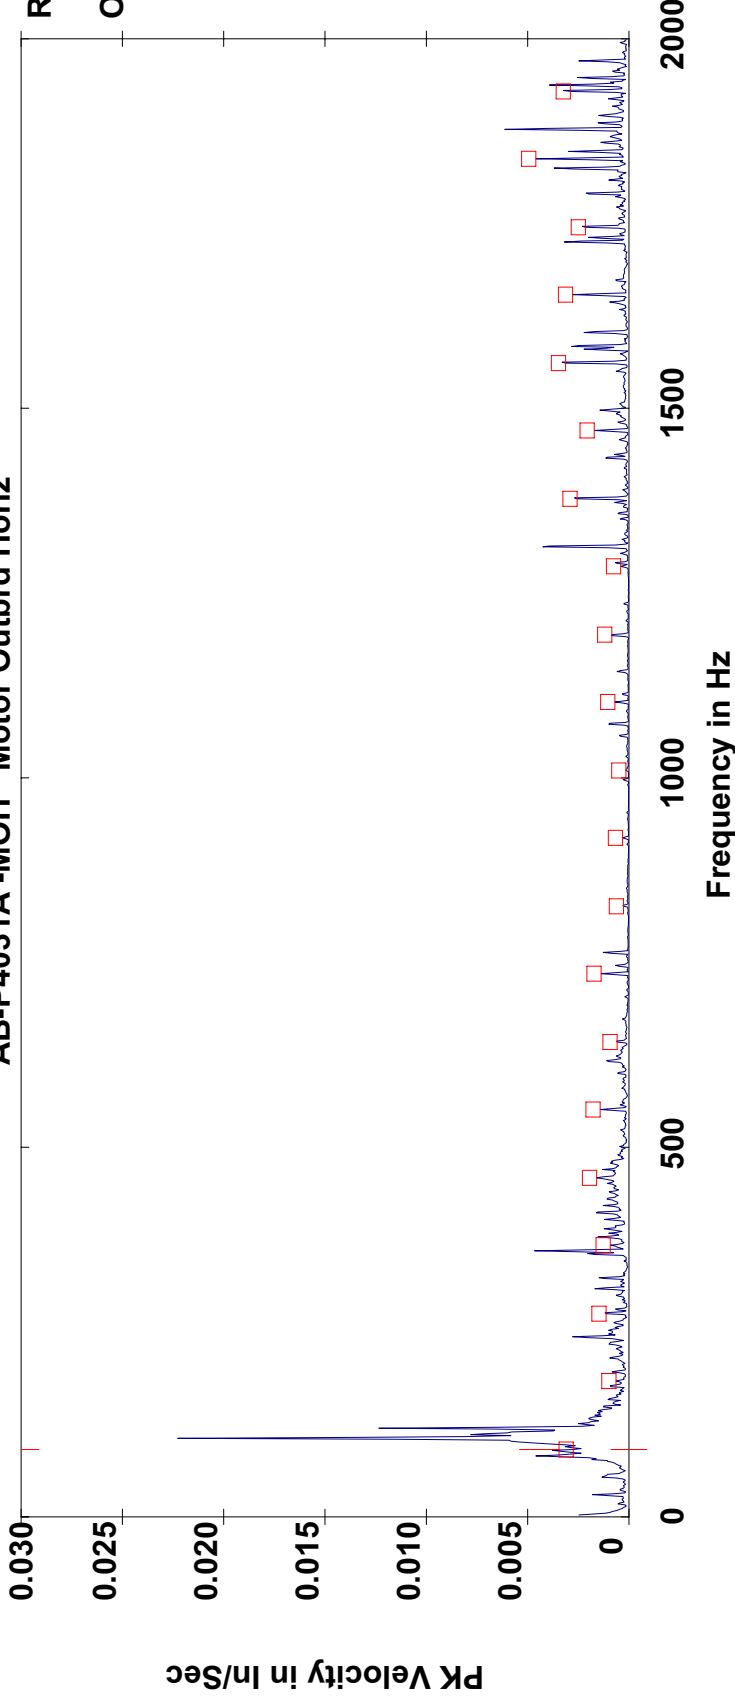
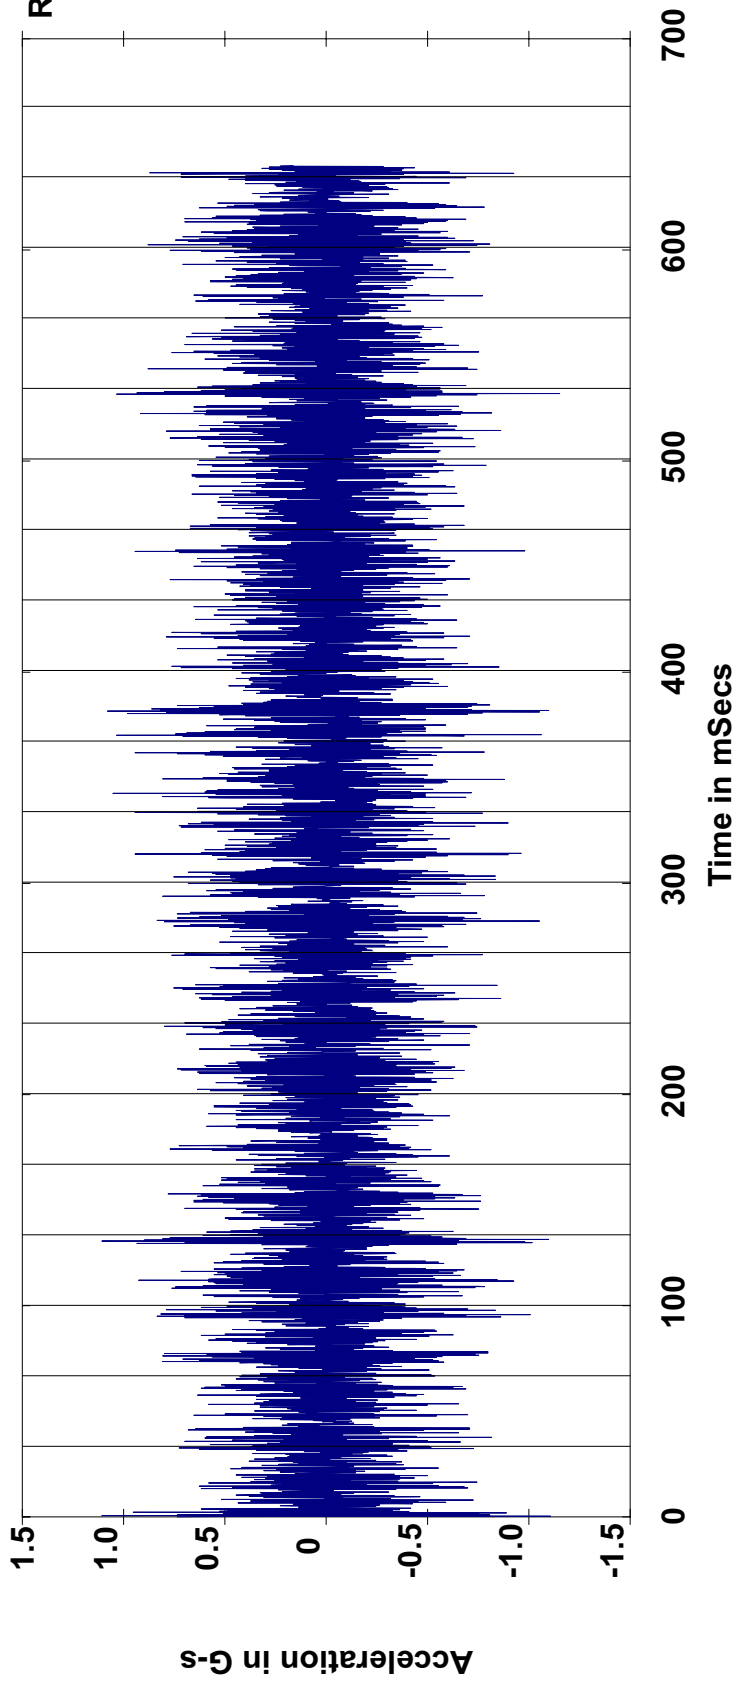
Label: FIGURE 1

- 1) Baseline vibration data collected on the motor test points indicates a very early stage outer race defect on both of the motor bearings. The levels of impacting are so low that the defect is probably not yet visible to the naked eye (FIGURE 1). One possible cause may be false brinnelling, a condition caused by ambient vibration on a stationary ball bearing which leaves impressions of the rolling elements on the outer raceway. False brinnelling typically occurs, for example, when a motor is shipped on a tractor trailer or stored in a warehouse without adequate vibration isolation or without the shaft being rotated by hand.
- 2) Belt condition and pulley alignment appears to be satisfactory.

- Gypsum Bleed Pump "A": Continue monitoring the bearing defects on the motor with vibration spectrum trending. No immediate corrective action is required.
- Gypsum Bleed Pump "B": Provide ISI with the pump bearing manufacturer and model number to verify the defect on the NDE bearing. Perform additional vibration trending to determine if the fault is worsening. Also, check bearing preload and endplay to ensure the bearing is not slightly bound or cocked.

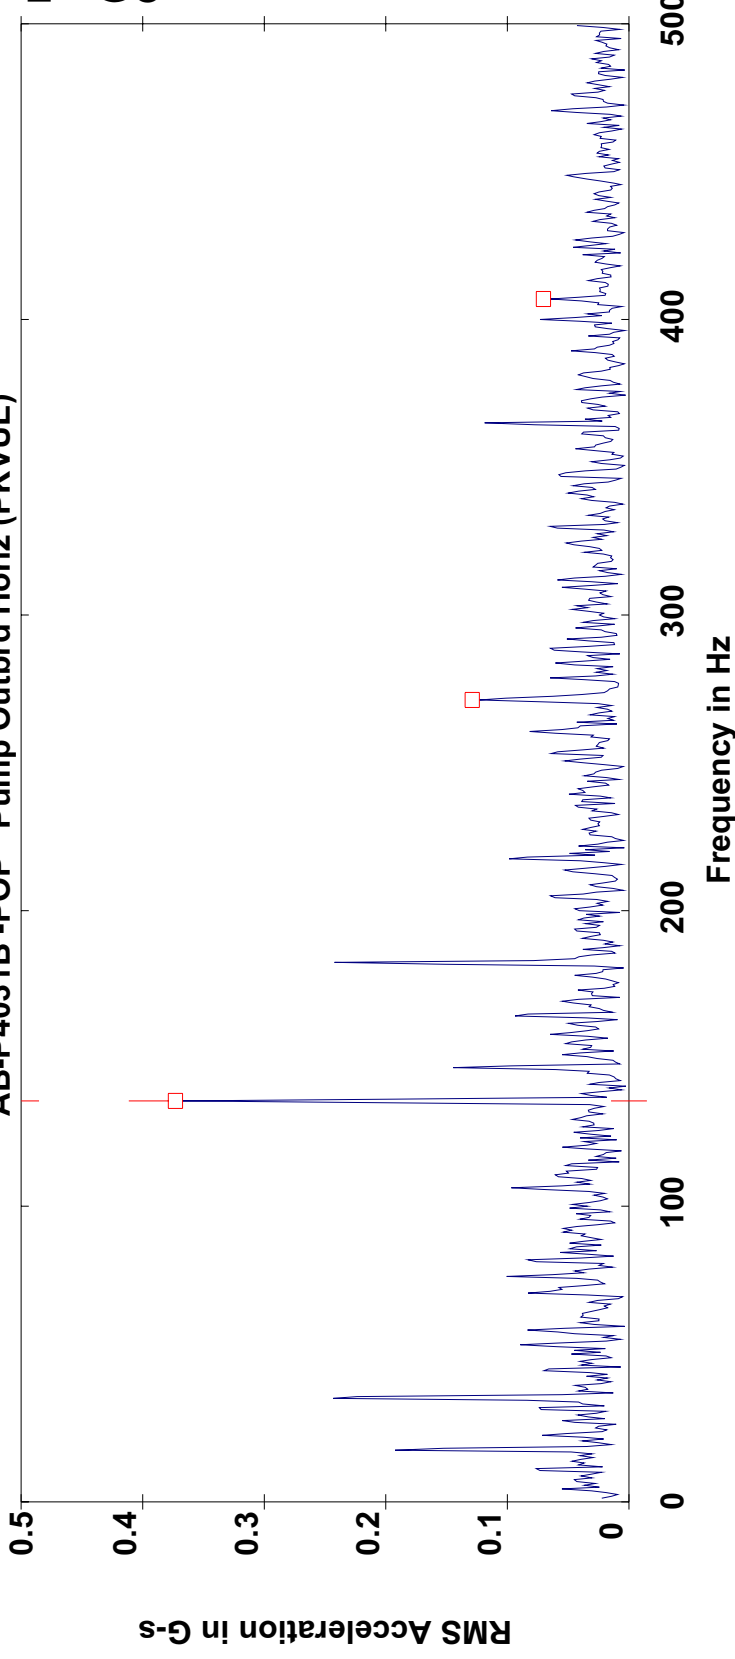
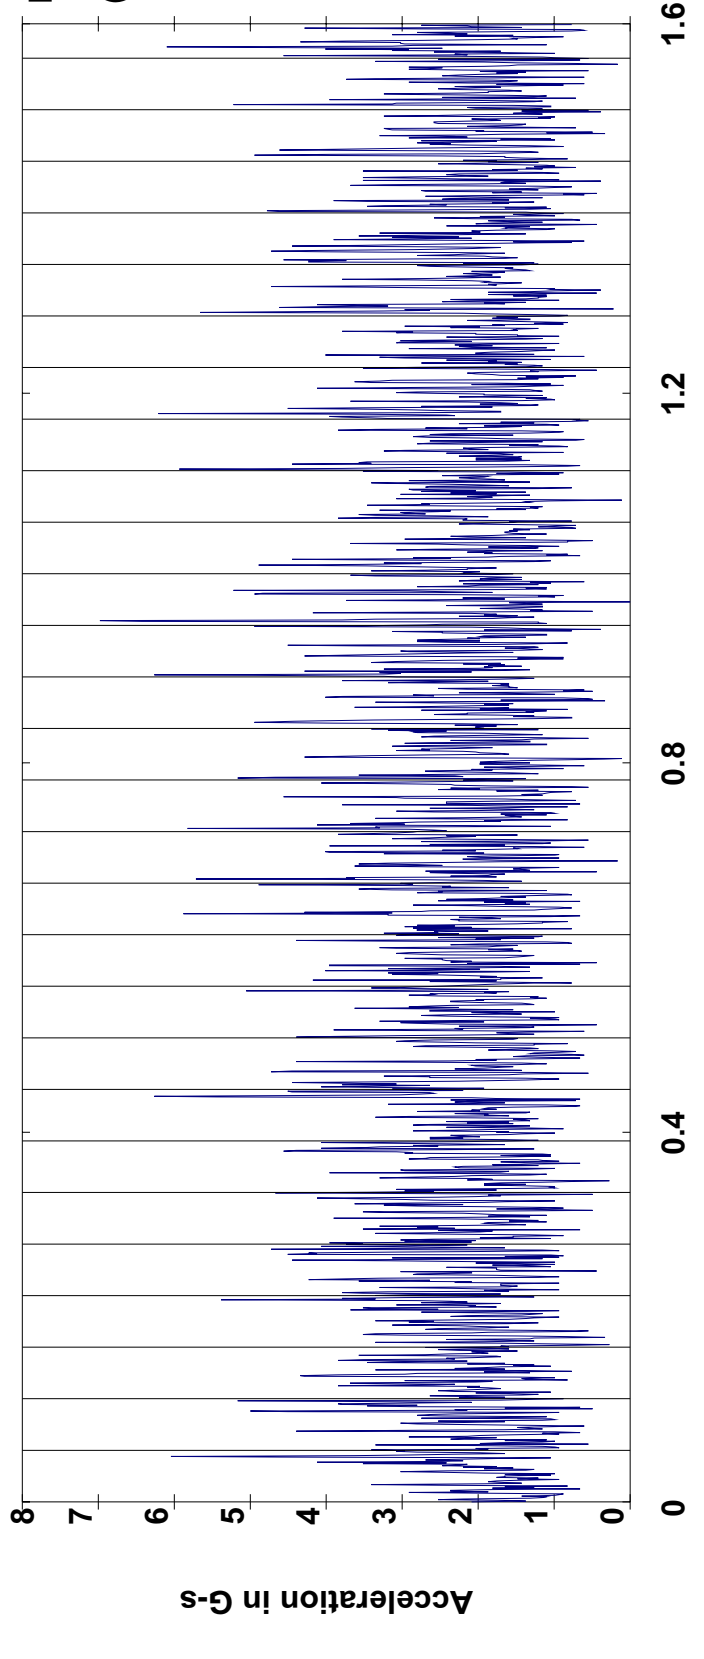
Label: FIGURE 2

- 1) Noted a moderate amount of metallic impacting occurring on the pump bearing housing, particularly on the NDE bearing (FIGURE 2). Levels appear to be about 4 times higher than those recorded on the "A" pump. The pump was run for an hour and bearing temperature did not exceed 128° F, which is well within specification (temperatures greater than 180° F would have been considered problematic and indicative of a lubrication issue). A stethoscope was used to listen to both pump bearings and an unmistakable, though muffled, mechanical clicking sound could be detected from the NDE bearing. The actual confirmation of this suspected bearing defect as well as the severity requires knowledge of the bearing manufacturer name and model number. Discharge pressure was 16 psig +/- 1 psig.

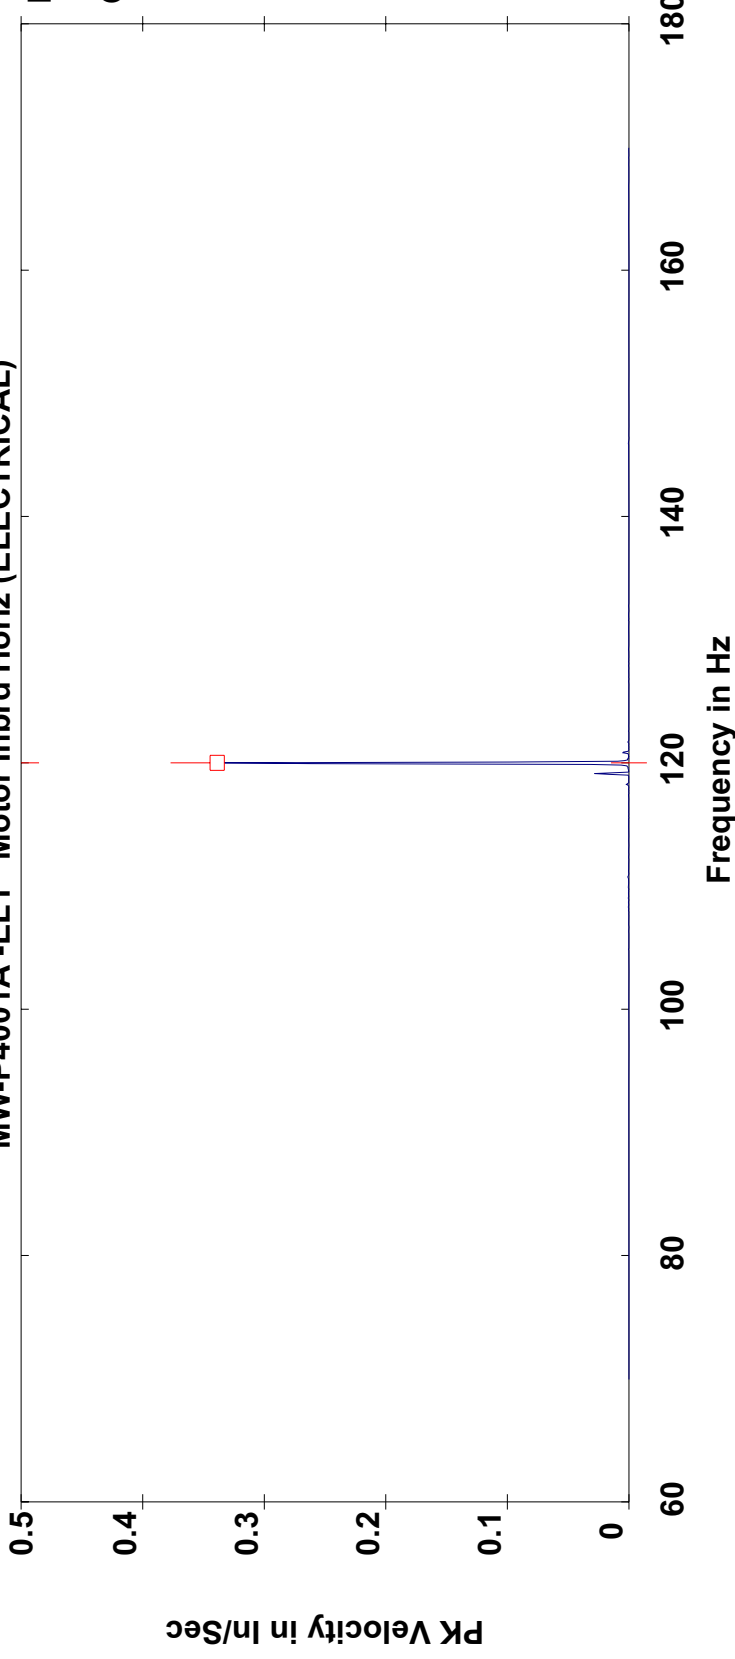
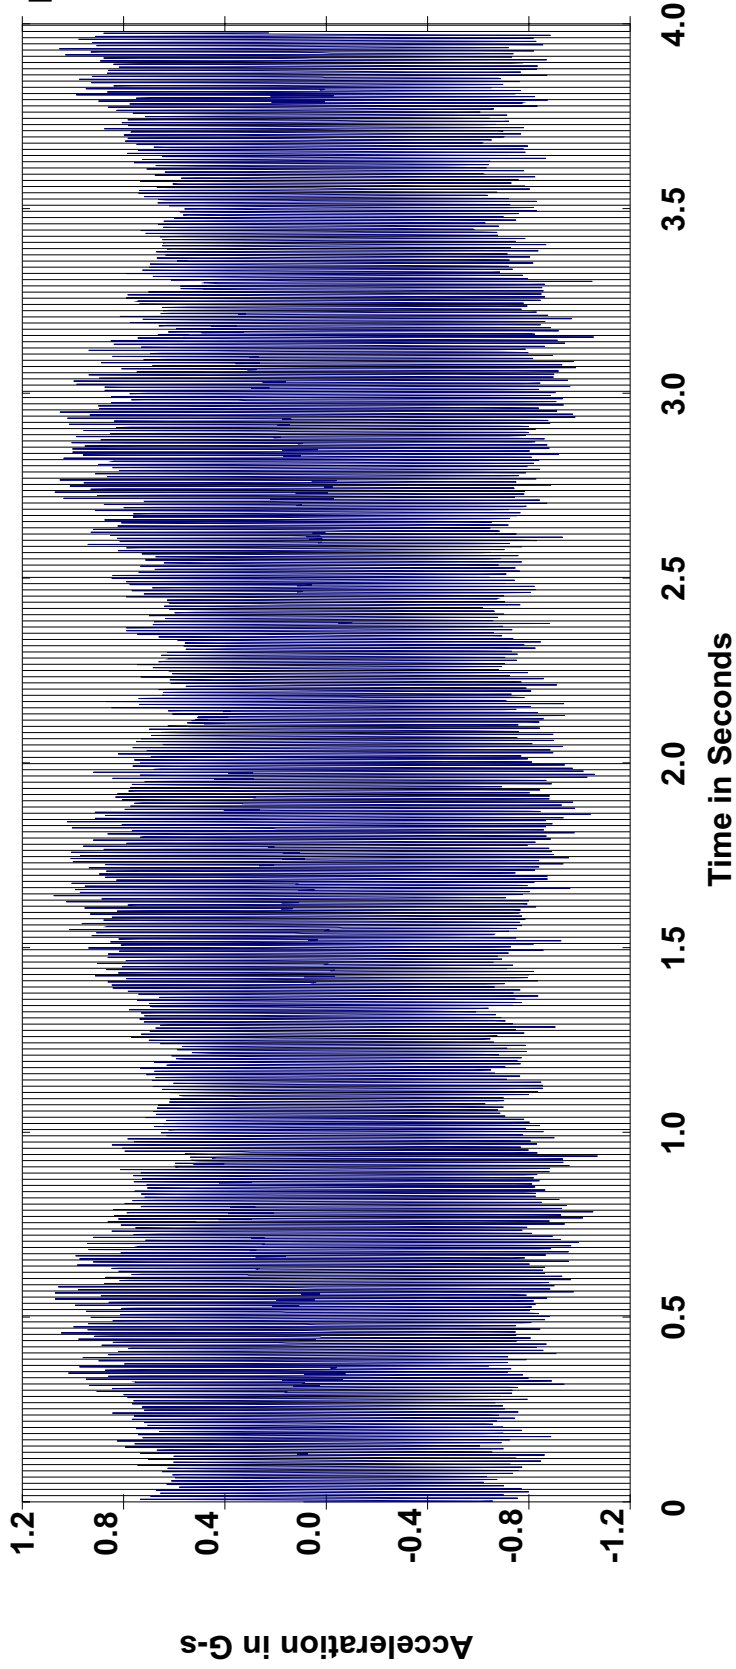
Label: FIGURE 3

- 1) Baseline vibration testing indicated excessive amplitudes of a vibration occurring at 120 Hz on several motor test points (FIGURE 3). While the motor was running, one of the motor foot hold down bolts was slightly loosened and a significant decrease was observed in overall vibration level. This is indicative of a softfoot condition due to either a defect with the motor feet or the baseplate being warped or twisted slightly. When the hold down bolt is tightened, it smashes the motor foot flat on the base and contorts the stator frame, resulting in an uneven air gap between the rotor and stator. This uneven air gap causes a vibration to occur at twice line frequency, or 120 Hz. The highest reading observed was 0.47 inches/second (IPS) on the motor DE bearing, axial plane. Efforts to check the alignment of the unit and shim the softfoot were unsuccessful, sometimes resulting in even higher levels. The alignment itself was ruled out as a problem when the motor was run uncoupled and no change was observed in the motor vibration. Furthermore, a “bump” test was performed on the motor to determine where the system natural frequencies were. It was discovered the natural frequency of the motor was within 10% of 120 Hz in all 3 test planes (FIGURE 4). This means that if a forcing function (such as softfoot) causes a vibration to appear within 10 – 15% of the observed natural frequency, this vibration can become significantly amplified in the manner of a tuning fork being struck. A bump test was also performed on the motor with the inboard left hold down bolt loose. Not only did vibration levels decrease by half, but the natural frequency shifted left and away from the softfoot vibration at 120 Hz (FIGURE 5). That is to say, the amplification factor was removed by changing the stiffness of the system. Long term operation in this condition without corrective action may result in excessive motor operating temperatures and premature failure of the motor bearings.

- Recommend using a machinist’s level to ensure the baseplate is flat in width and length, particularly where the motor feet sit. Flatness should be within 0.002 inches/foot. Machine the surface as necessary to achieve this standard.
- Fill the baseplate in with non-shrinking grout and allow to cure before making any further adjustments. Contact the pump vendor for further assistance on this, or consult a foundation specialist. Additional modifications to the foundation may be necessary to have the desired effect on the natural frequency and ultimately the overall vibration level.
- Verify the motor feet sit flat on the baseplate and use a dial indicator mounted to the baseplate and contacting the motor shaft to determine if softfoot exists. Repair as necessary.
- Perform vibration acceptance testing on the motors both uncoupled and coupled to determine the effectiveness of the repair.
